# March 2010 FEE Engineering Run at CTIO/Tololo

DARK ENERGY  
SURVEY

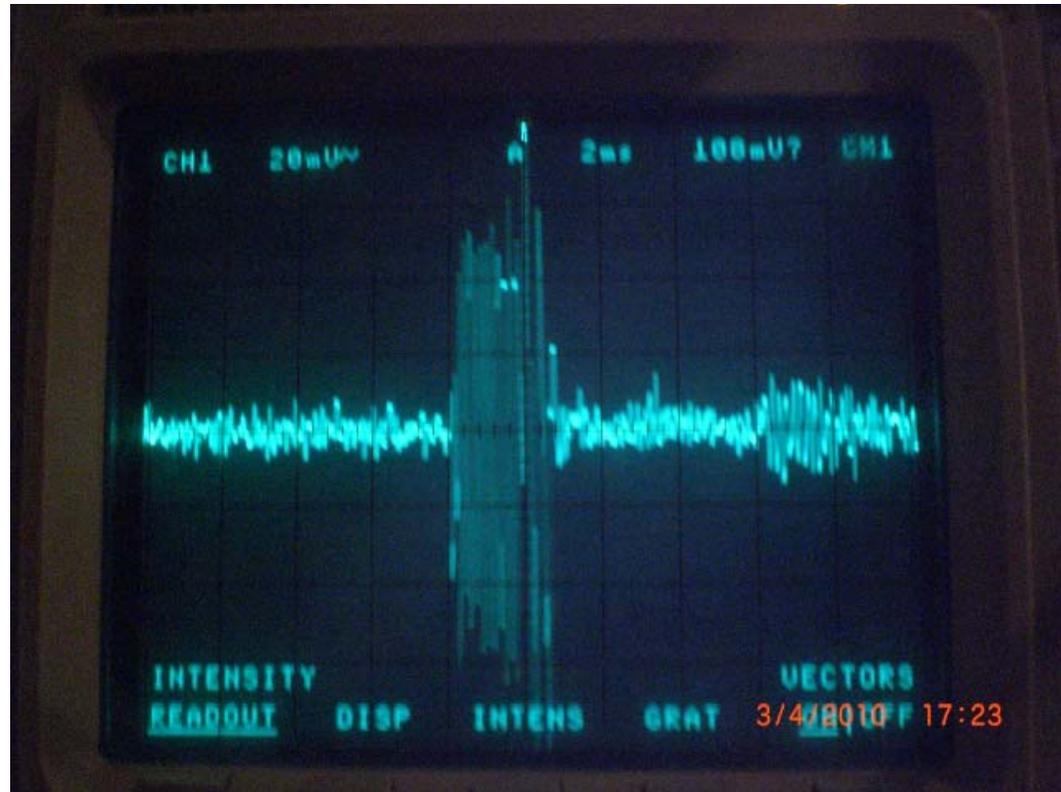
CM noise (on GND wire) with MDVRs OFF. Scope triggered on an ESD event while working around the crate. Otherwise, the noise observed is less than 20 mV(p-p).

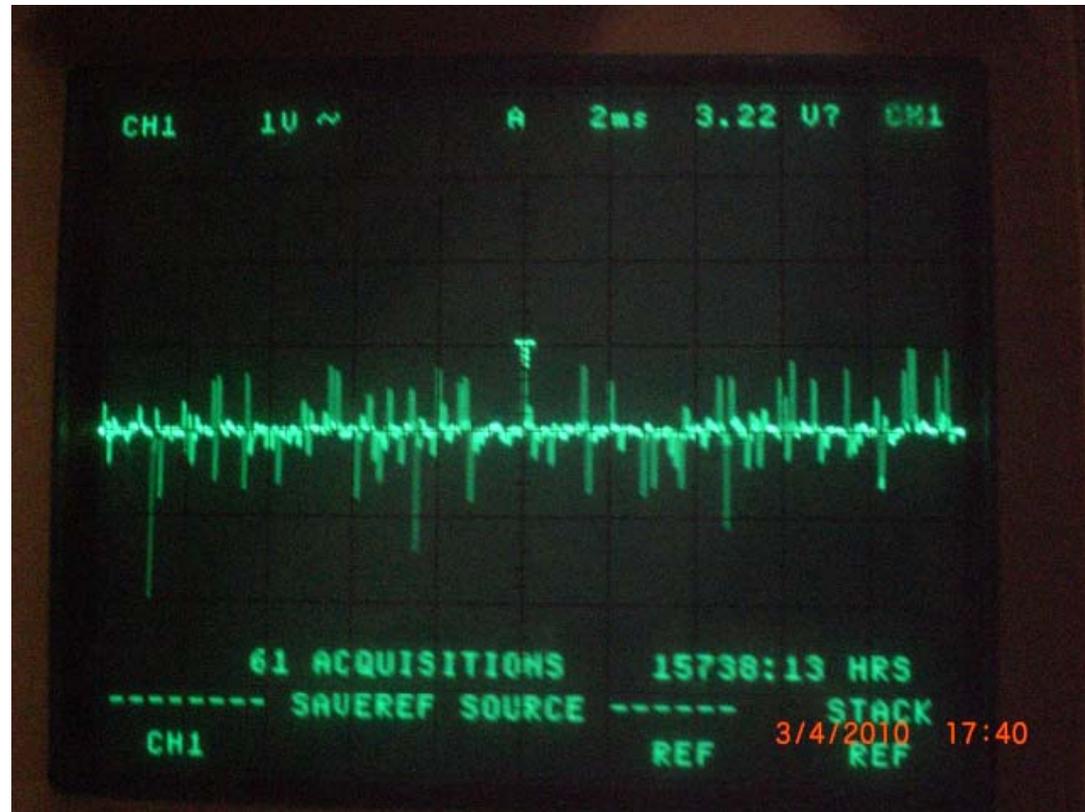
CM noise (on GND wire) with MDVRs ON. Noise observed indicated the familiar spikes in the range of 20-30 V<sub>peak</sub>.

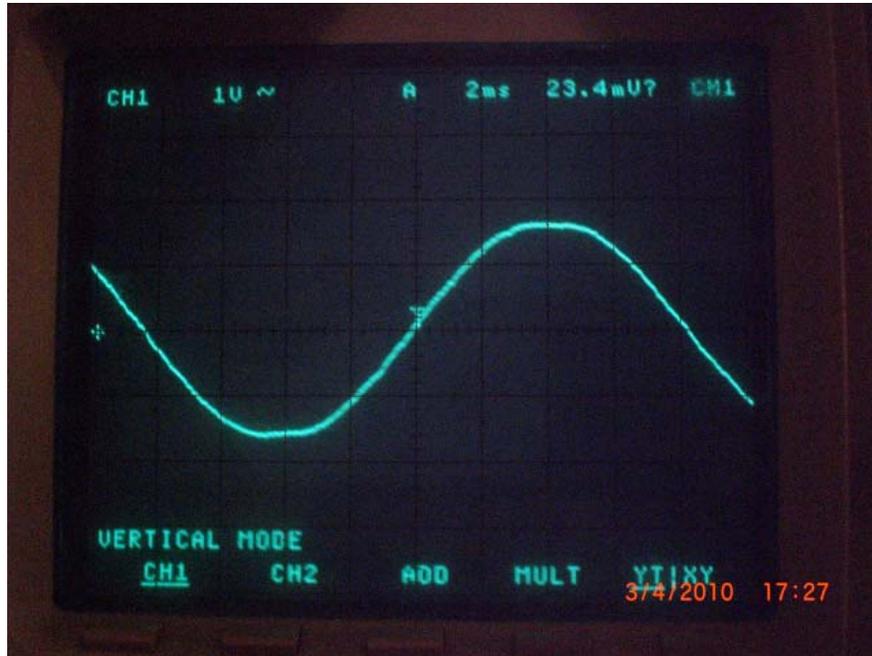
Line voltage observed with the MDVRs OFF.

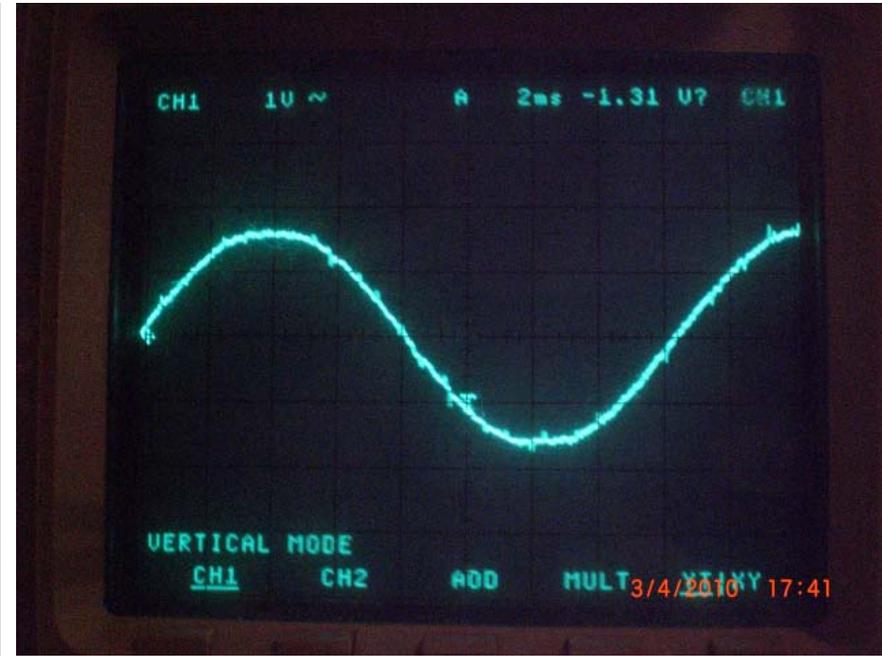
Line voltage observed with the MDVRs ON. (Same spikes appeared.)

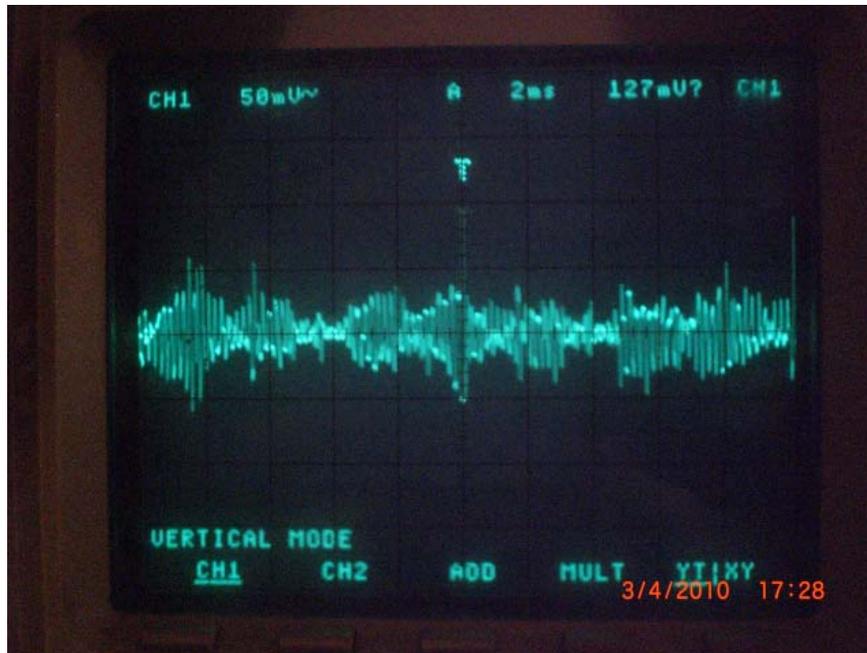
DM noise (on the neutral wire)  
observed with the MDVRs OFF.

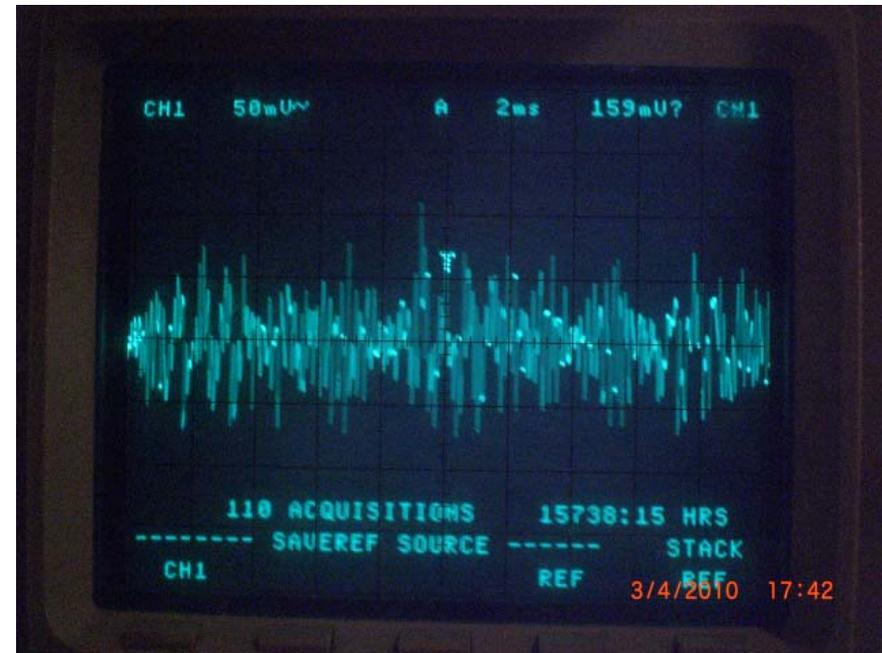
DM noise (on the neutral wire)  
observed with the MDVRs ON.

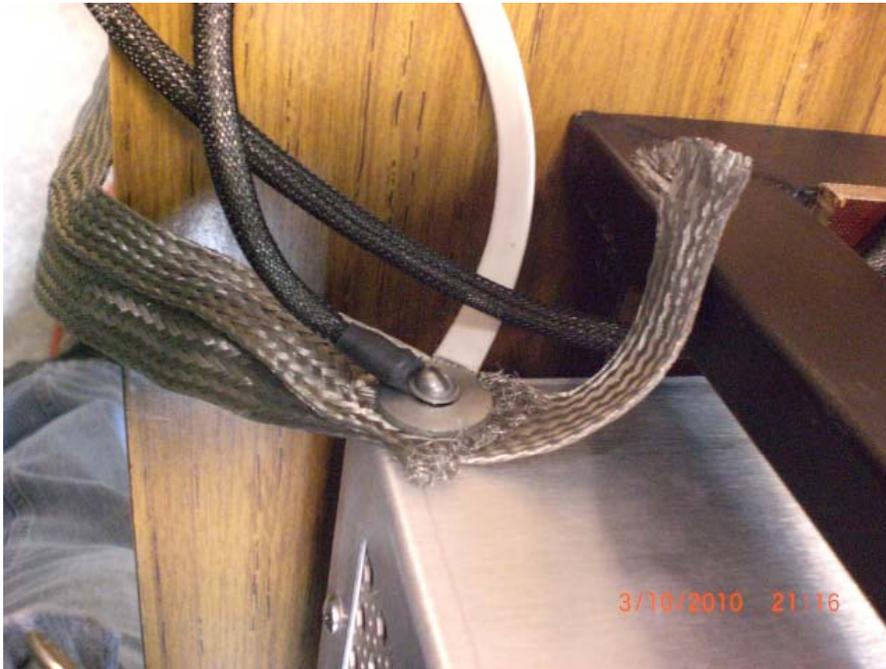
Create showing braid star grounding point.

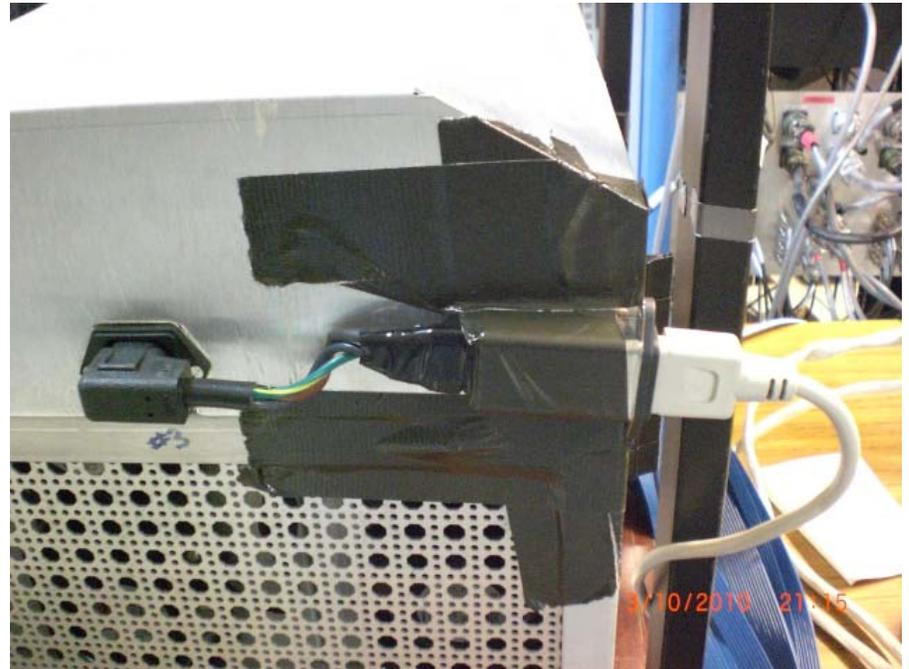
Installation of the PEM with earth-choke.

- Next, mounted a 2-stage inline power filter. This produced a marginally better ADU count to 10.9 and 16.9.
- Took out the 2-stage filter and placed in series with the switched power entry module (PEM), a PEM with an earth choke. This brought the ADU count to 7.1 and 7.3 (MDRVs ON and at about 23:00).
- Verified the gain to be at 1.00 and 1.03. The ADU count for successive readouts stayed between 8.1 and 9.6 for the rest of the night (up to 02:00).
- The CM noise on the line viewer varied a bit but not as much as last November '09. However, the noise count stayed below 9.5.

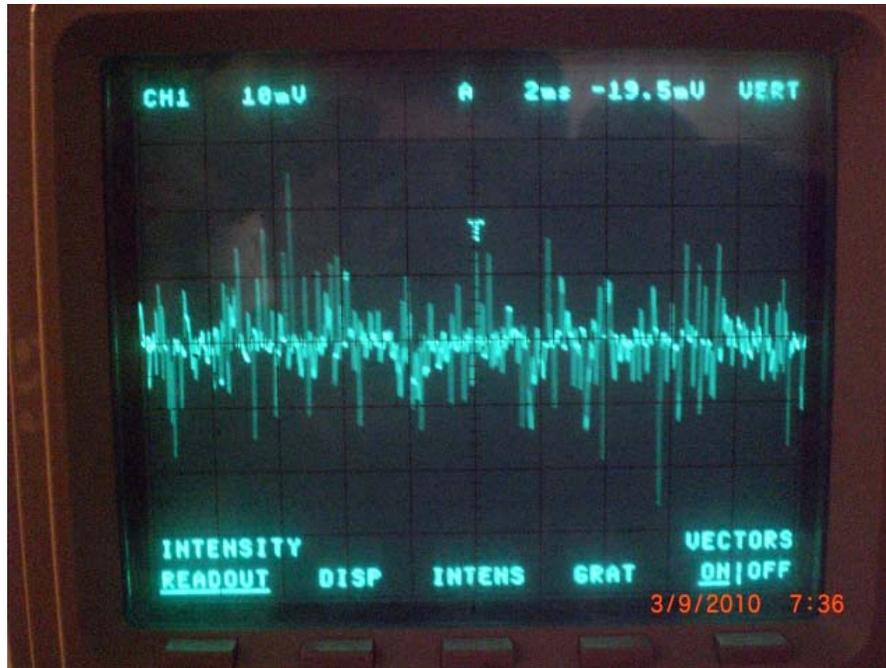
CM noise viewed with the Schmidt MDVRs ON. The waveform pattern looked similar to that seen at the 1M. This did not change during the night or during observation hours.

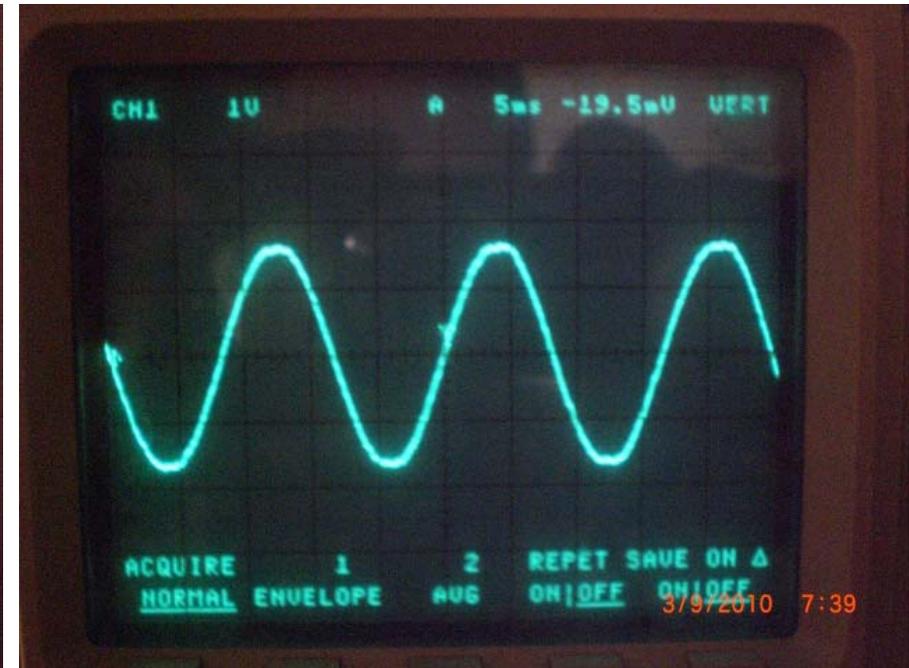
Line voltage waveform, from the UPS outlet on the telescope, viewed with the Schmidt MDVRs ON. Stayed clean throughout the observation period.

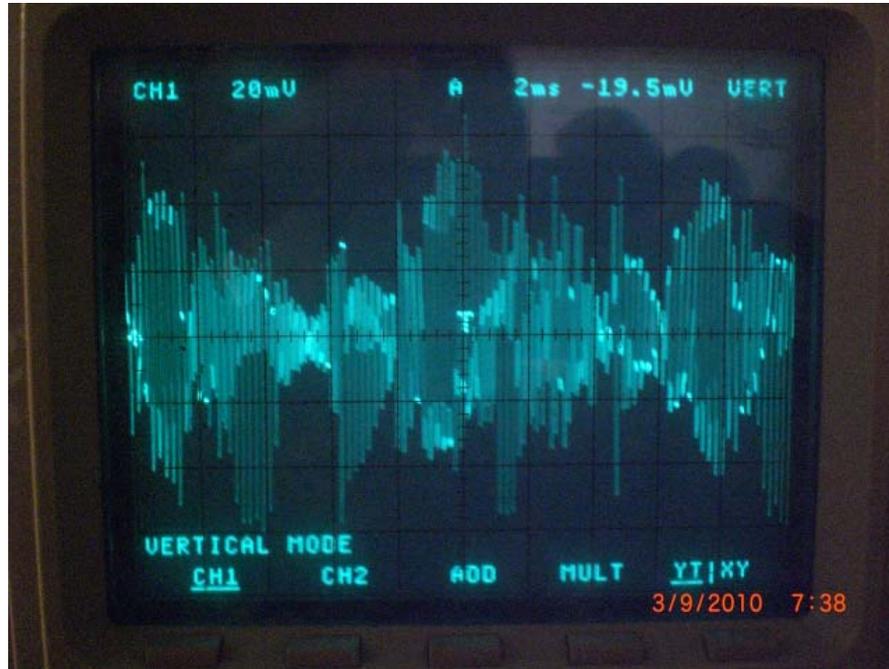
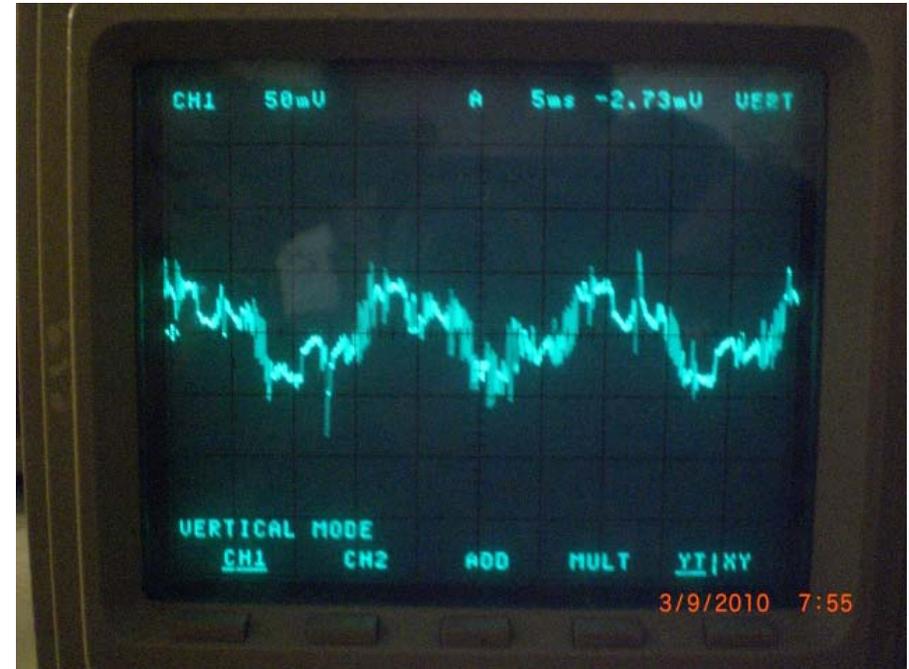
DM noise viewed with the Schmidt MDVRs ON. The waveform patterns changed while these pictures were taken. Sometimes, the waveform would go flat. However, no large peaks were observed.

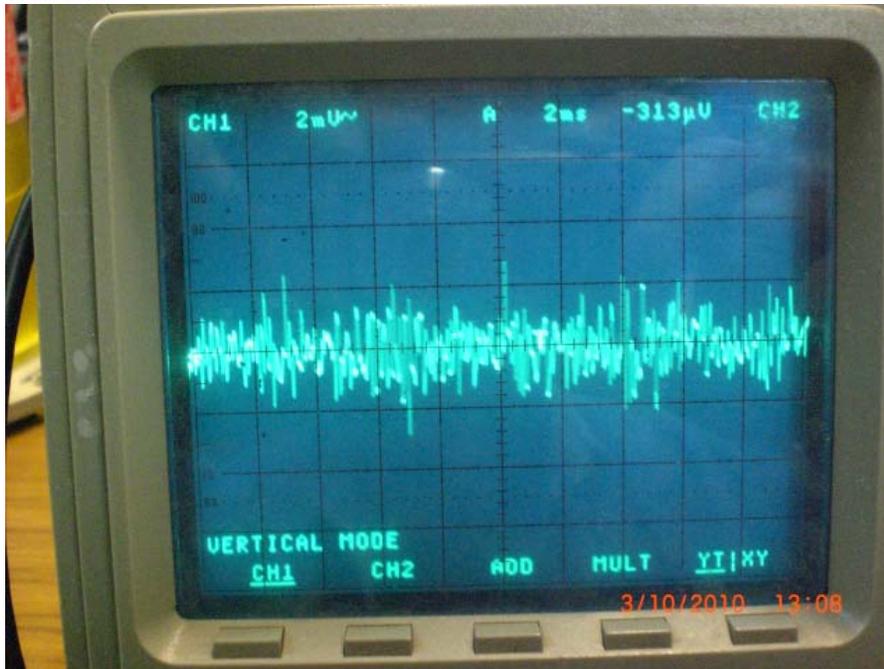
CM noise viewed in the Blanco 4M. The peaks were less than 30 mV. This did not change when the MDVRs were switched ON or when the telescope motors were running.

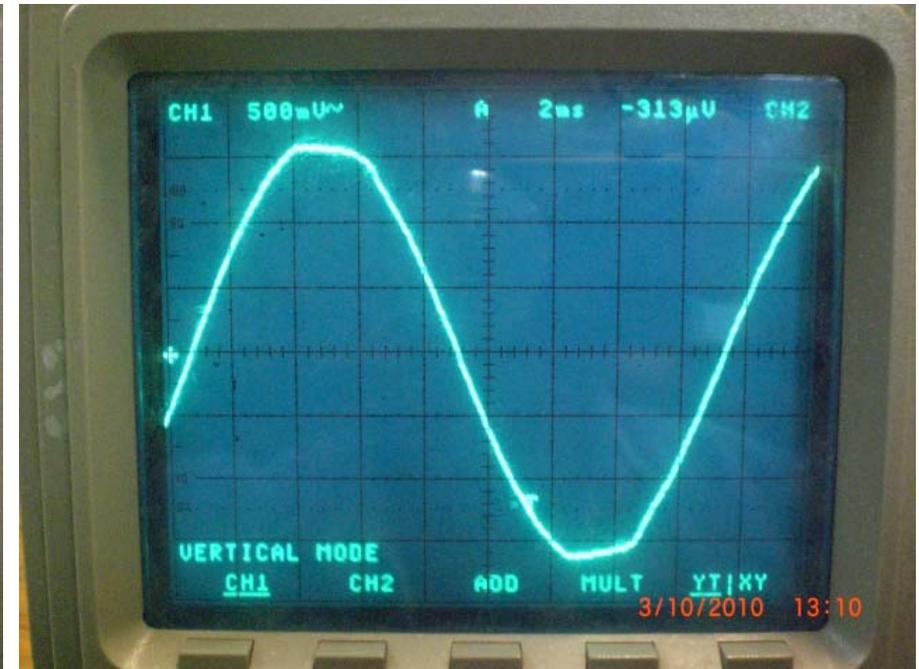
Line voltage waveform from the UPS outlet in the Blanco 4M building. Stayed the same throughout the observation period (MDVRs ON or OFF).

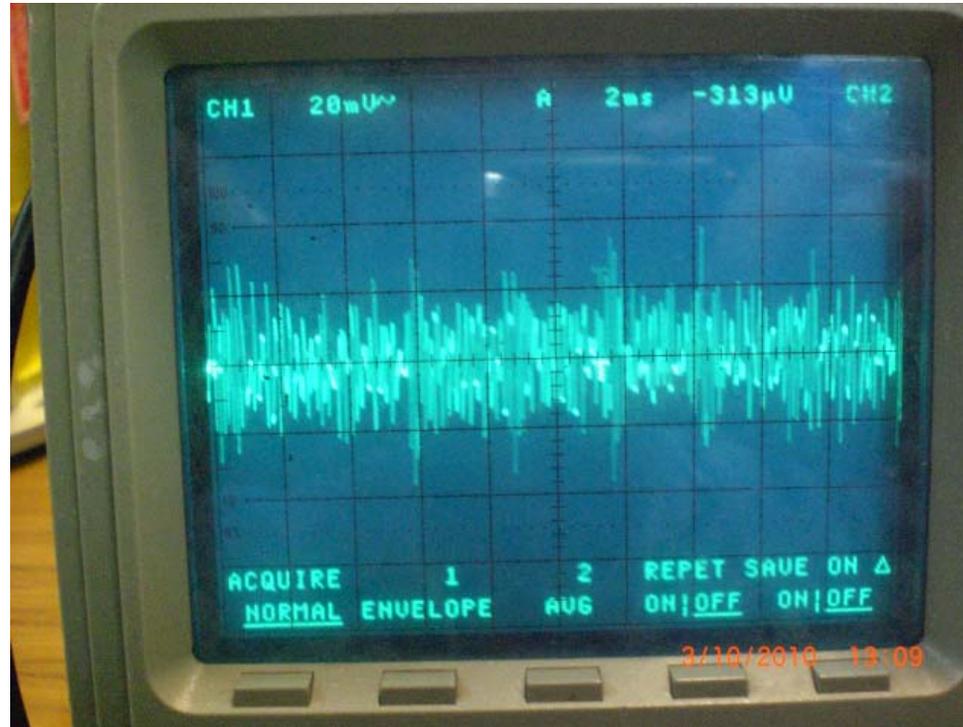
DM noise viewed in the Blanco 4M building. The waveform also did not change throughout the observation period.

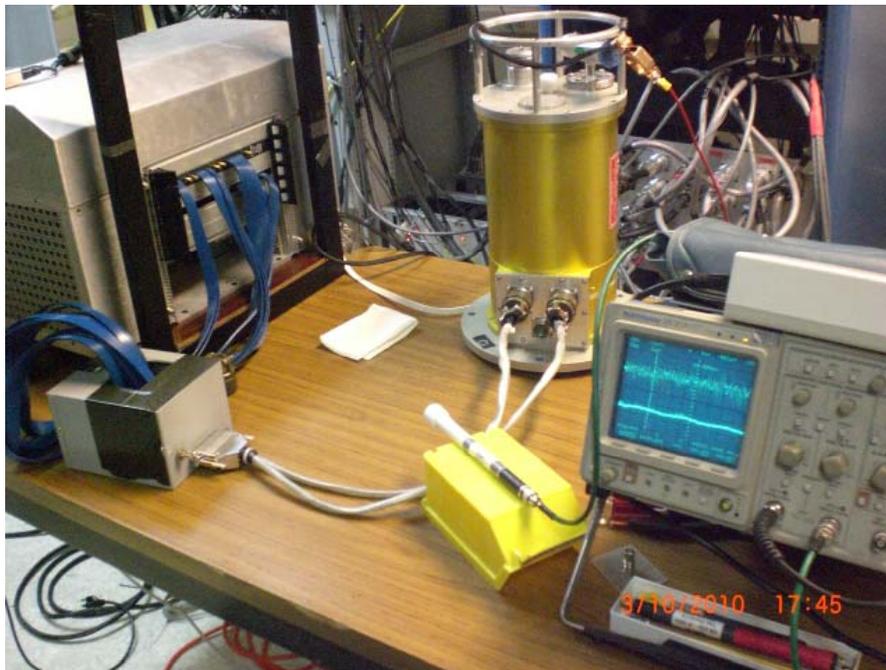
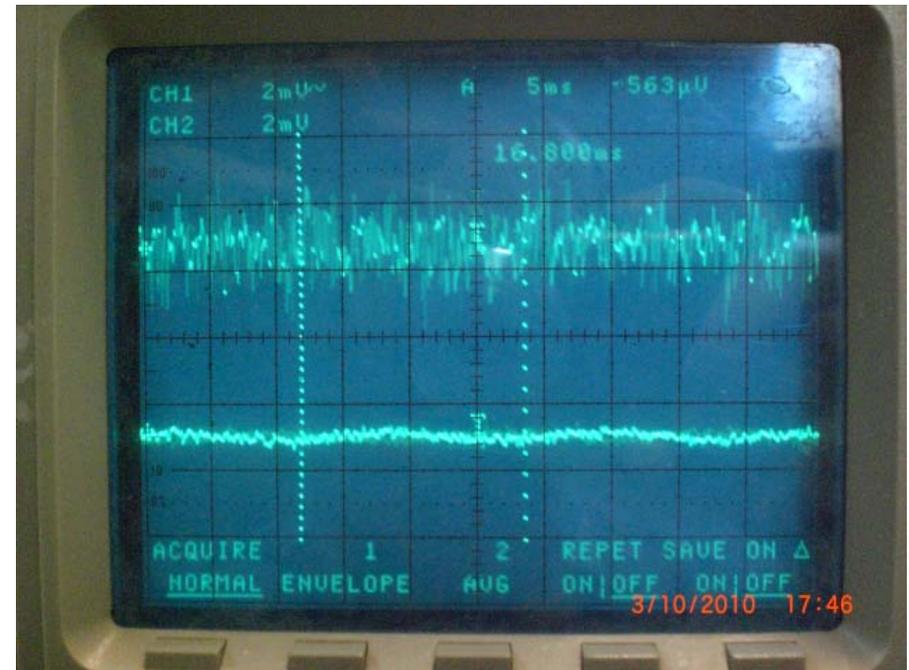
Checked the CM noise on the line viewer and used an E-field probe to check for fields during the observation. Did not observe any large noise waveforms.
