# AC Power and Grounding Observations During the Nov'09 Electronics Run

DARK ENERGY  
SURVEY

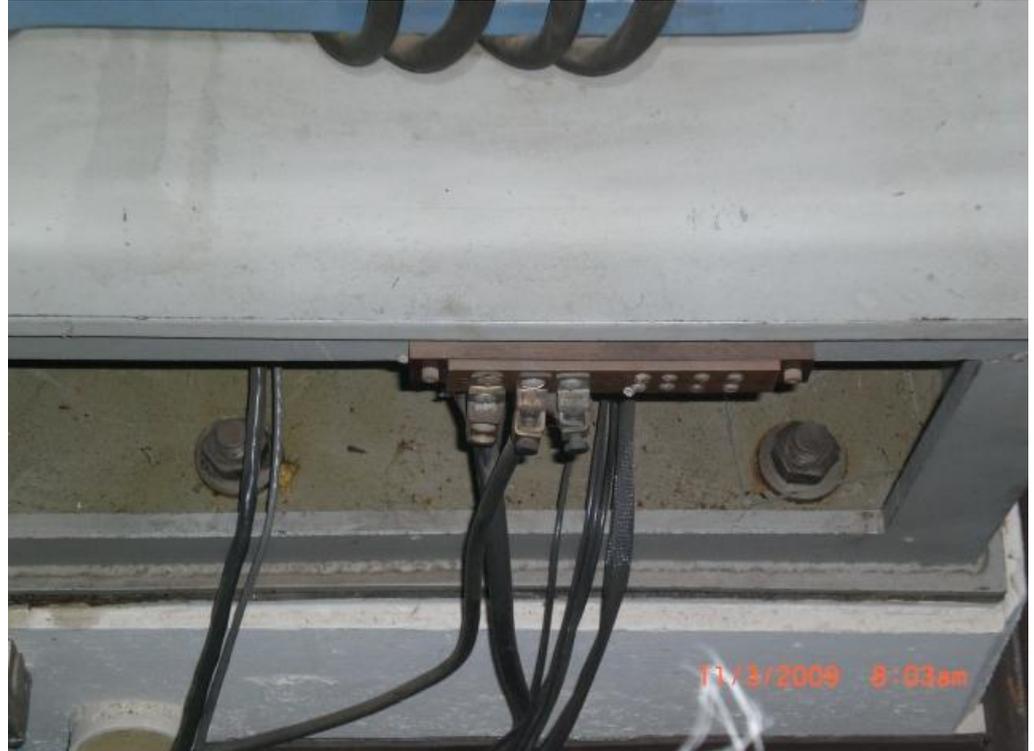
- Initial assessment continued:
  - There is an instrument grounding block that is isolated from the telescope and platform metal and is connected solely to a long buried earth ground cable outside of the building. This is currently not used.

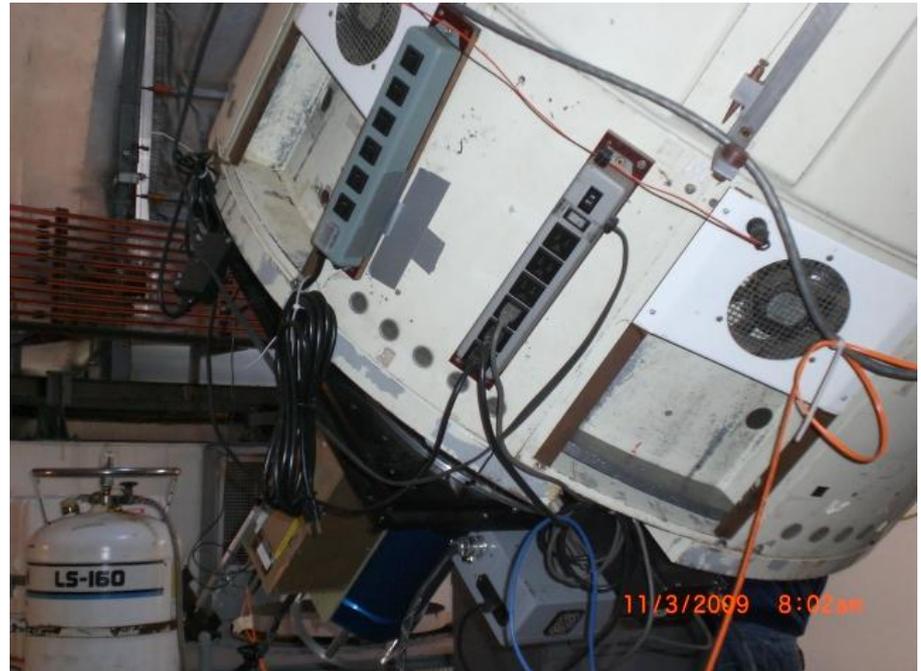
- Initial assessment continued:
  - The safety ground conductor's resistance reading between the UPS powered equipment strip and the telescope's metal measured at 0.5 ohms indicating a very hard (metal-to-metal or short wire) bond even though the strip's metal body is not directly bonded to the telescope metal.

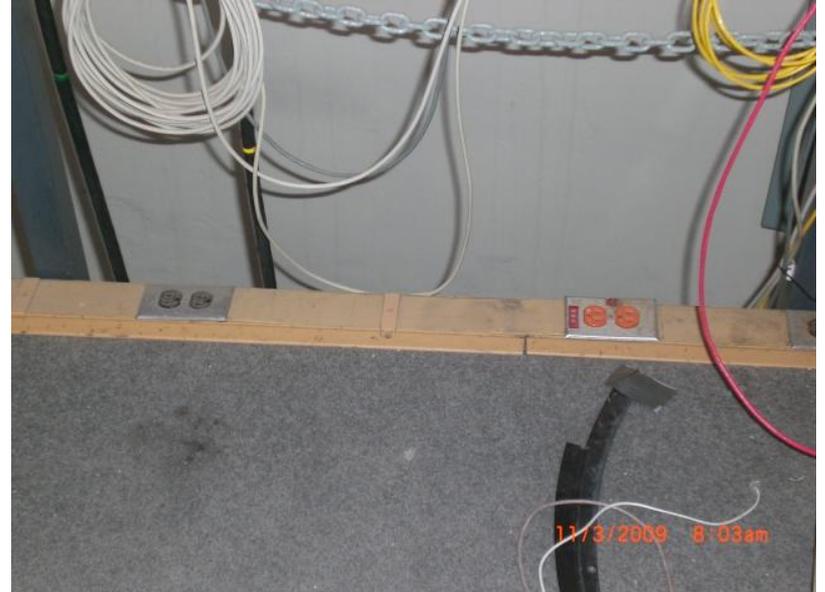
- Initial assessment continued:
  - Using a line viewer for observing the UPS power, both on the telescope and the platform, indicated a very clean voltage waveform and no detectable power to neutral (DM) or neutral to GND (CM) noise (less than 200 mV). These readings were NOT affected by platform operation.
  - The line viewer indicated a distorted voltage waveform and DM and CM noise spikes on the building power, further verifying that this AC is NOT to be used for scope or instrument power.

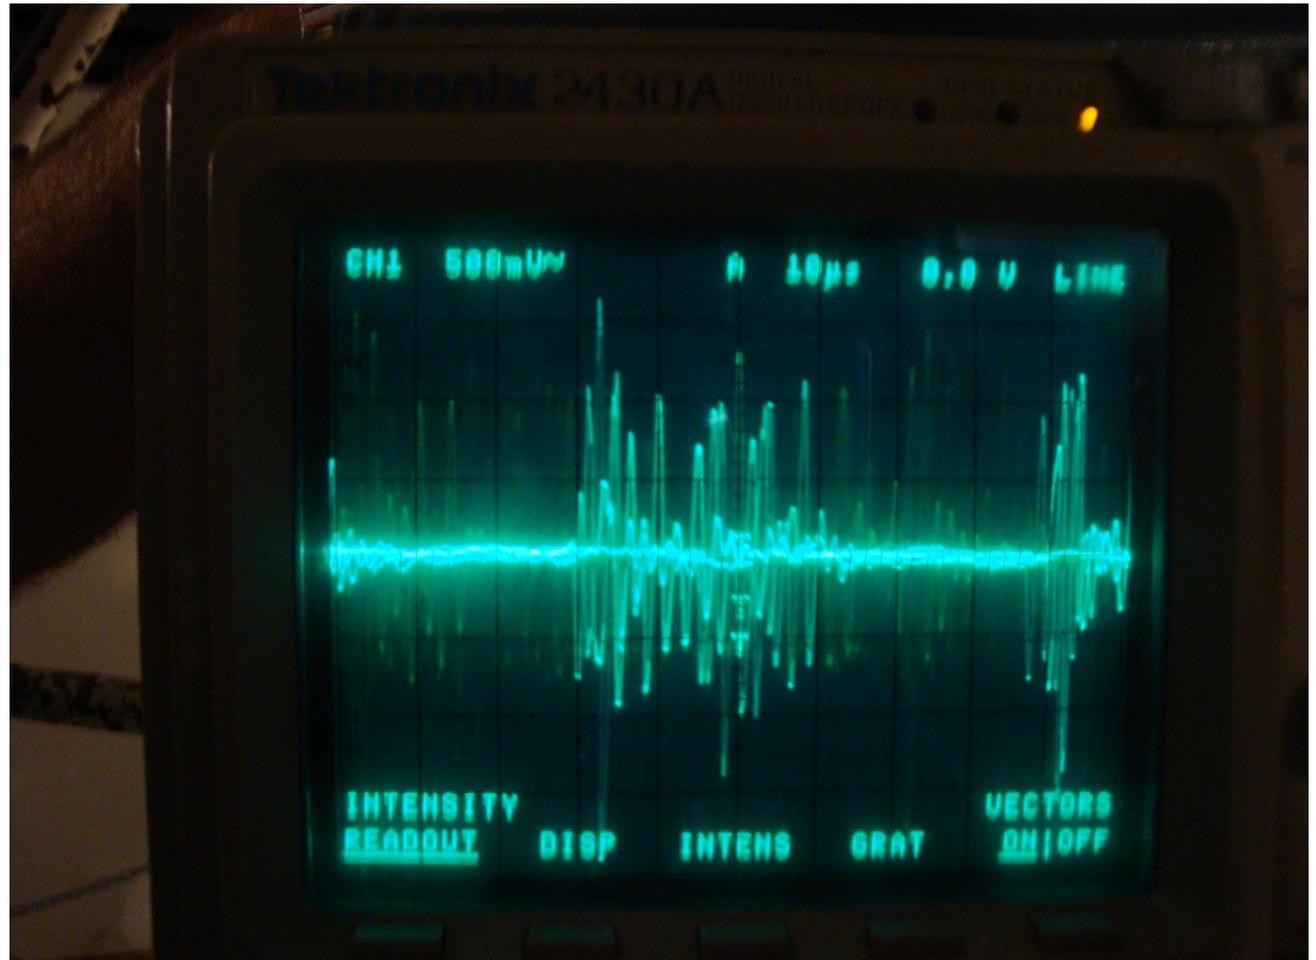
Scope is looking at the common-mode (CM) noise seen by the line viewer (LV) with the tracker controllers/motors on.

Large spikes seen are between 15 and 20 volts peak.

- Conclusions:
  - The small line filter did not help much. Even the portable UPS output filter was insufficient to filter out the CM noise seen.
  - The noise count is a direct result of conducted noise from the AC power input. The common mode noise can be seen on the cable shields and is most probably coupling into the signal path.
  - This noise on the UPS power clearly shows that as things get turned on in the 1-meter building and in other buildings as well, the line noise gets progressively worse and more unpredictable.
  - The means of filtering the AC power coming to the crate needs to be greatly enhanced, either by using a much better line filter at the crate, by using a line conditioner at the UPS panel and a dedicated branch circuit for the electronics, or by using both.

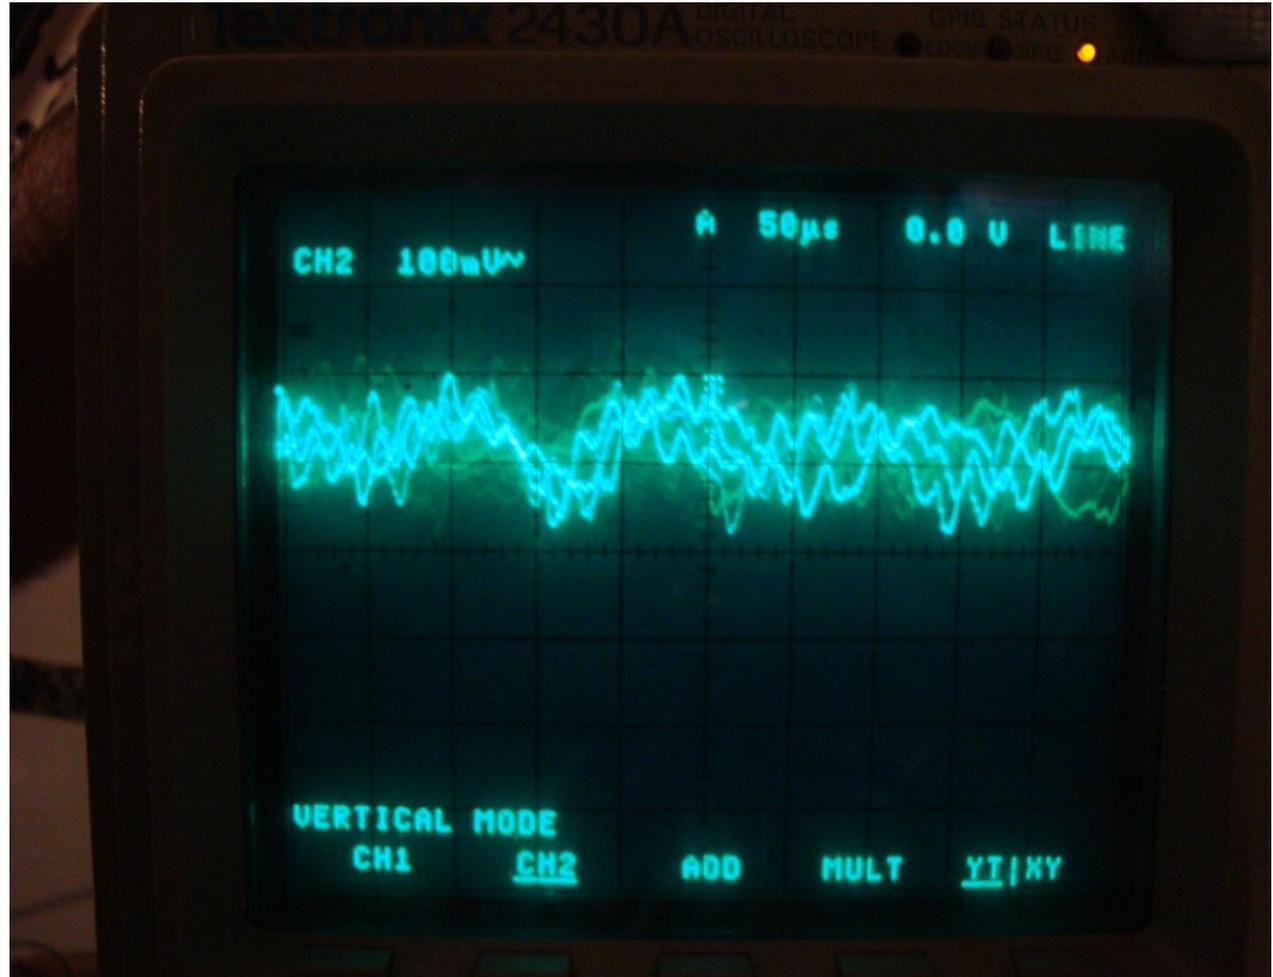
Scope is looking at the differential-mode (DM) noise seen by the line viewer (LV) with the tracker controllers/motors on.

Large number of HF components but low level: less than 2 volts peak-to-peak.

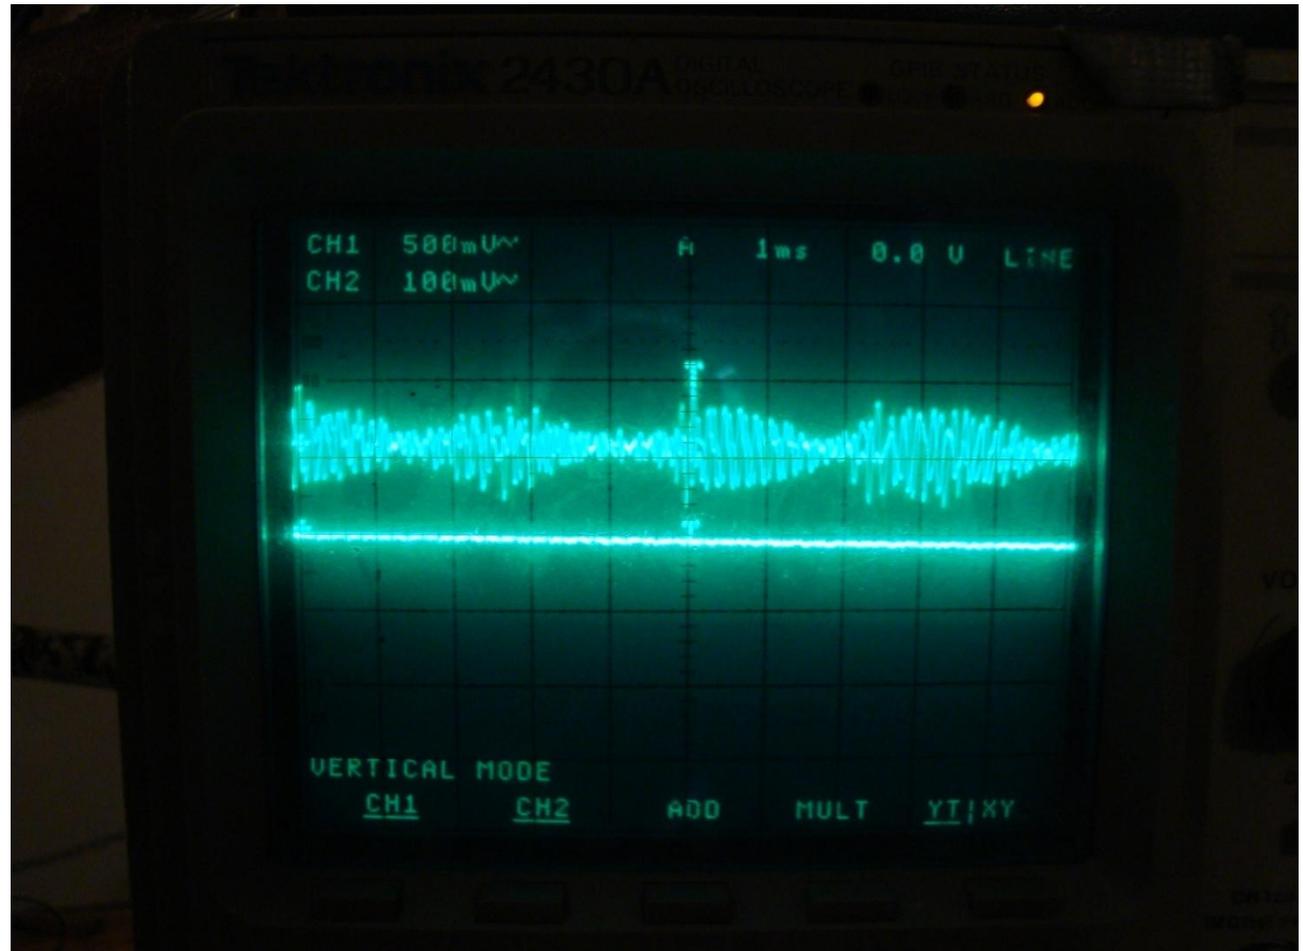
Scope is looking at the CM and DM noise seen by the line viewer (LV) with the tracker controllers/motors off.

The CM noise waveform disappeared. The DM noise waveform did not change much.

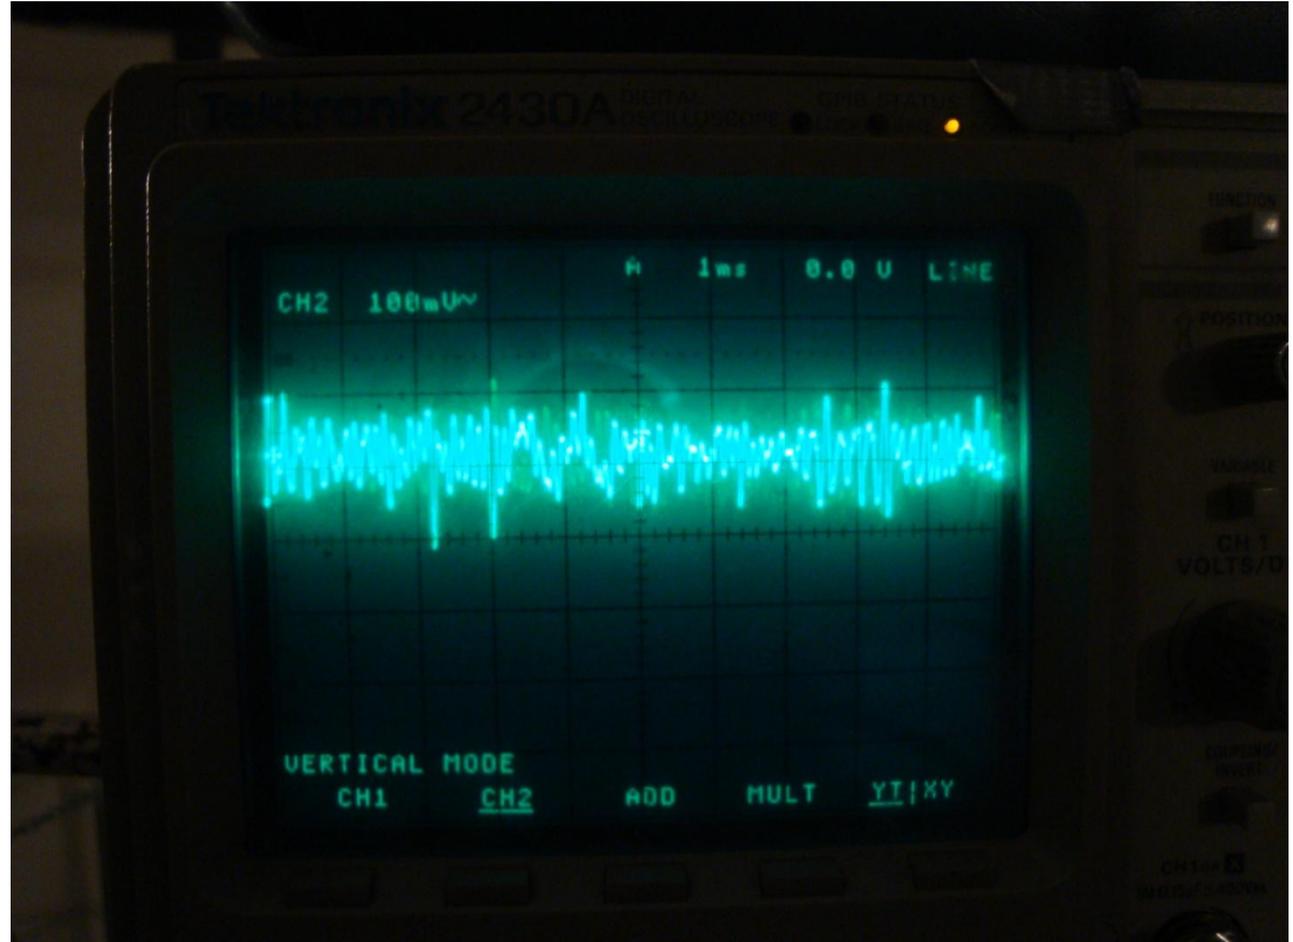
Scope is looking at DM noise with the controllers/motors off.

The noise count increase to about 60. Then this waveform disappeared and went back to as before. It seems another source of line noise was observed.

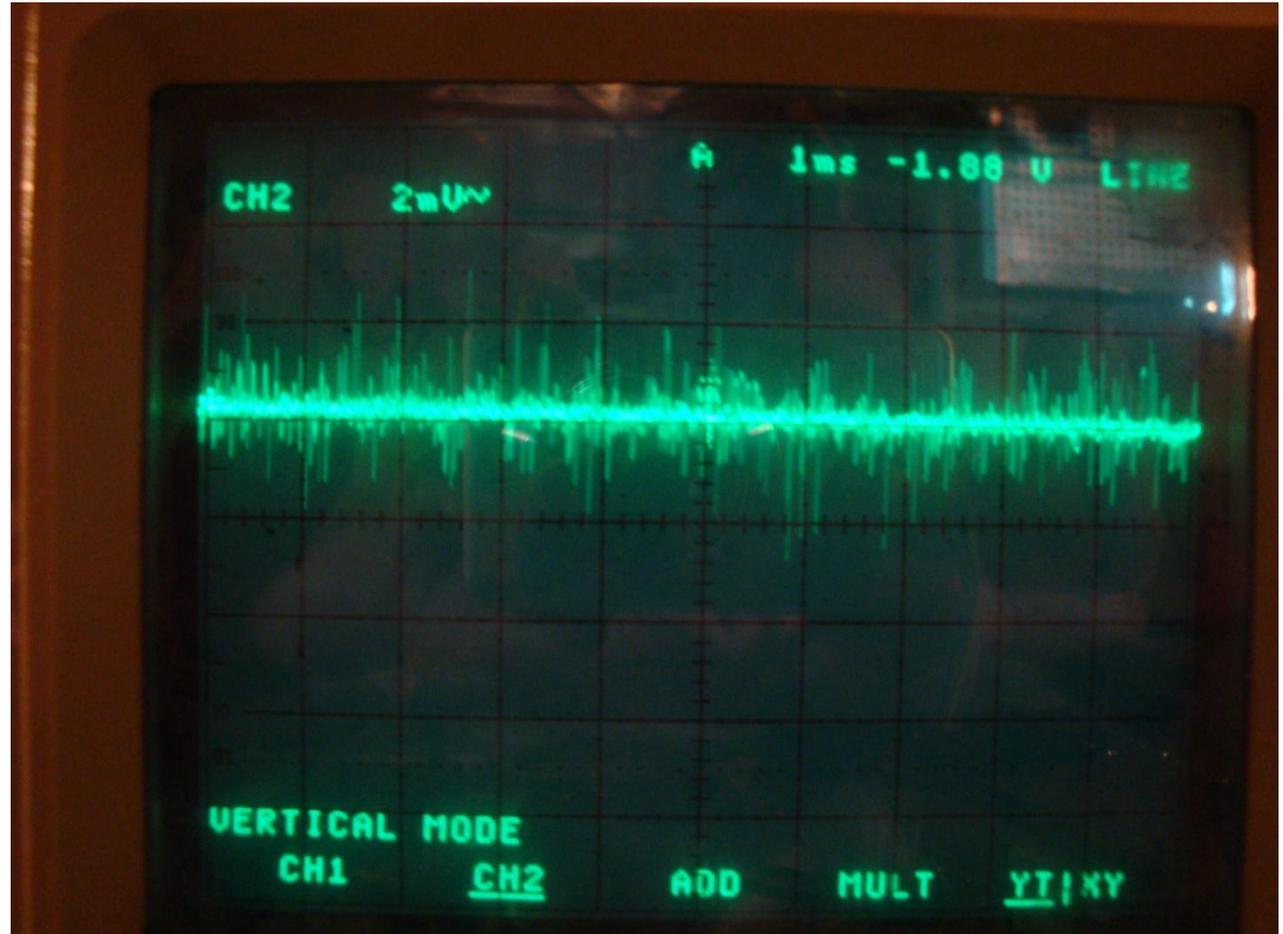
With the tracker controllers/motors on, use a H-field probe and located this noise on the cable shield as it is terminated by the dewar's circular connectors. This noise almost exactly duplicates the pattern seen on the CM noise using the line viewer.

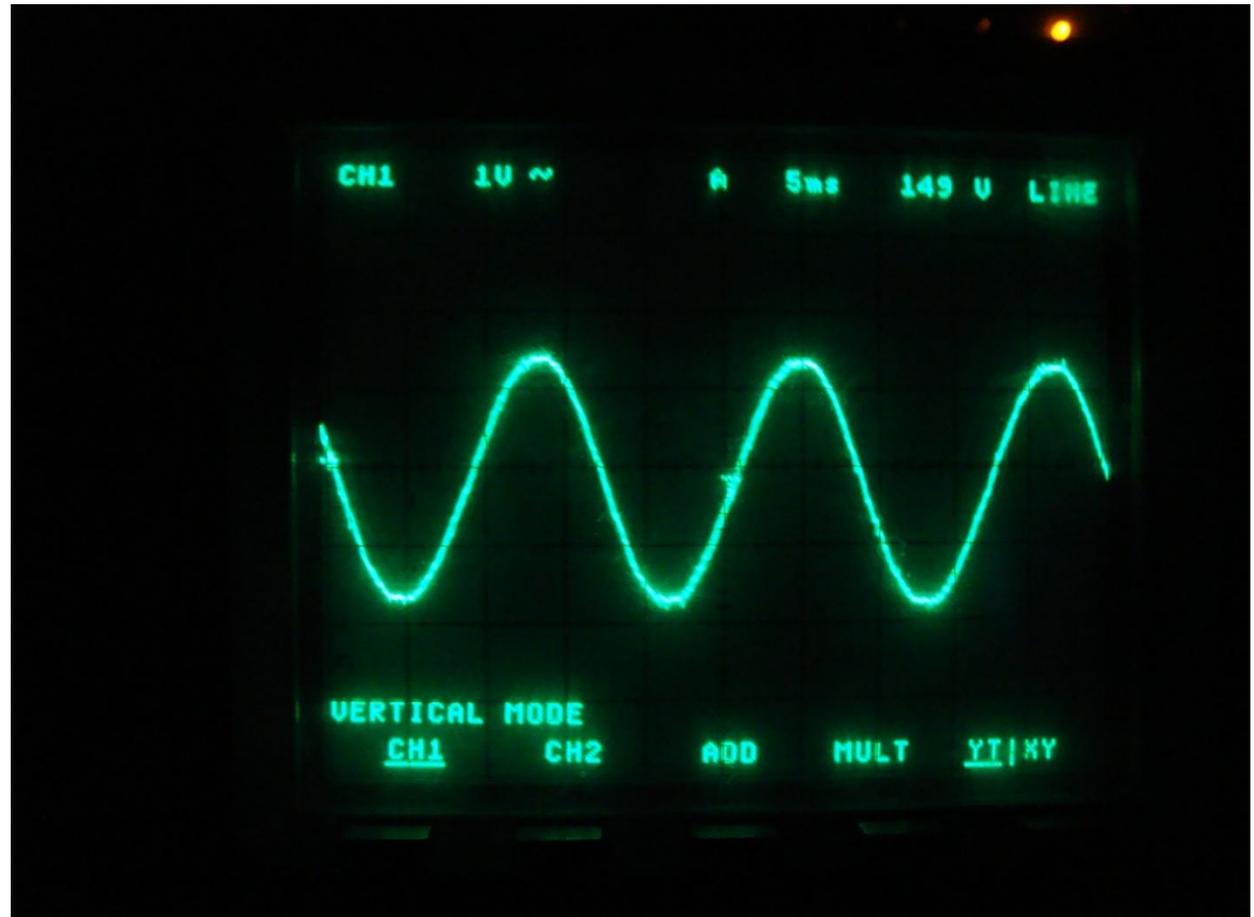
Now, looking at the voltage sine-wave, small hash spikes can be seen at the peaks. These were not there before. Something new is now affecting the incoming AC power.

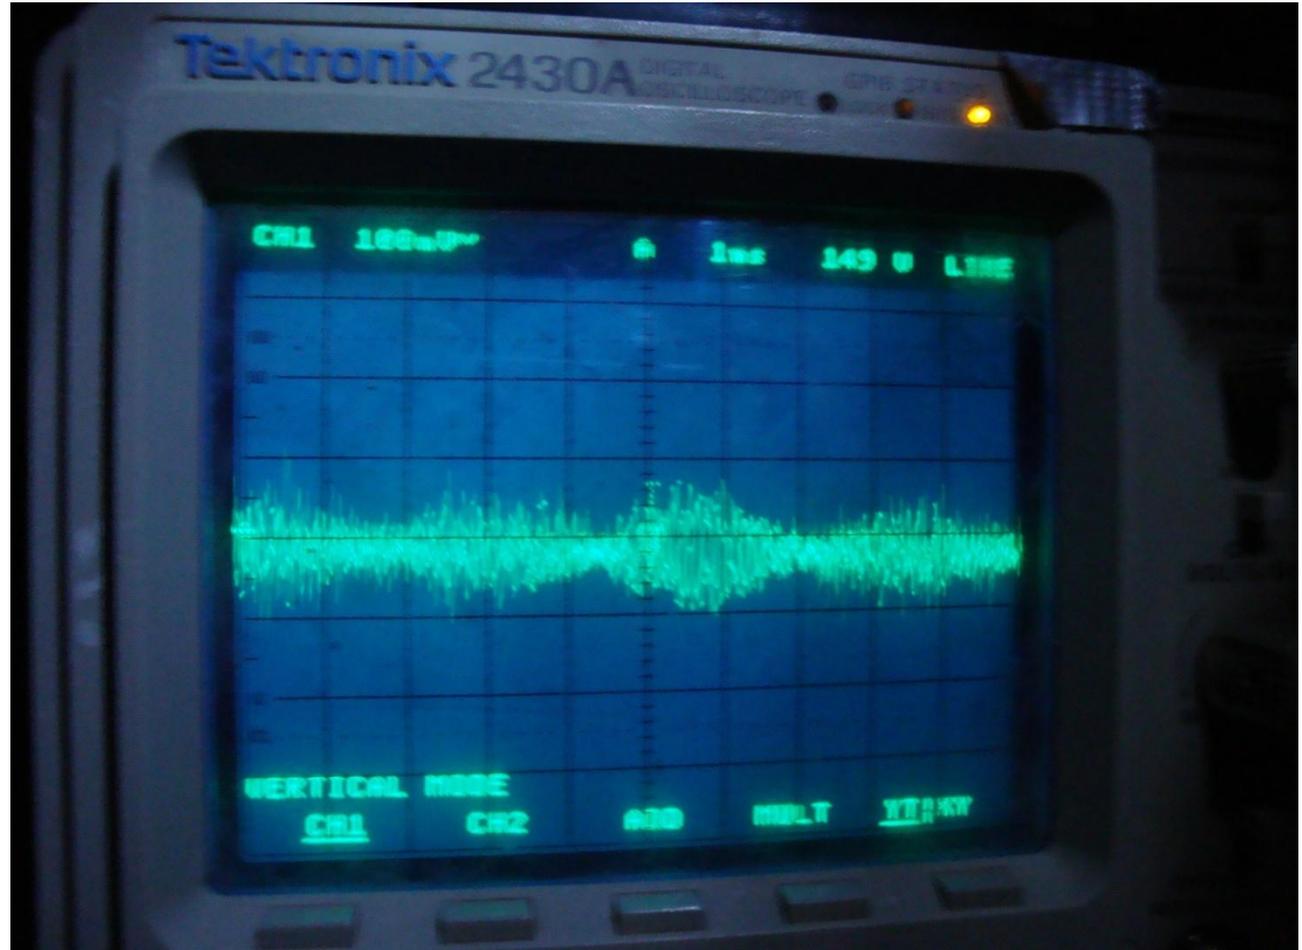
The DM noise has not increased in amplitude ( $< 2$  volts p-p) but there appears to have been a significant increase in HF components.

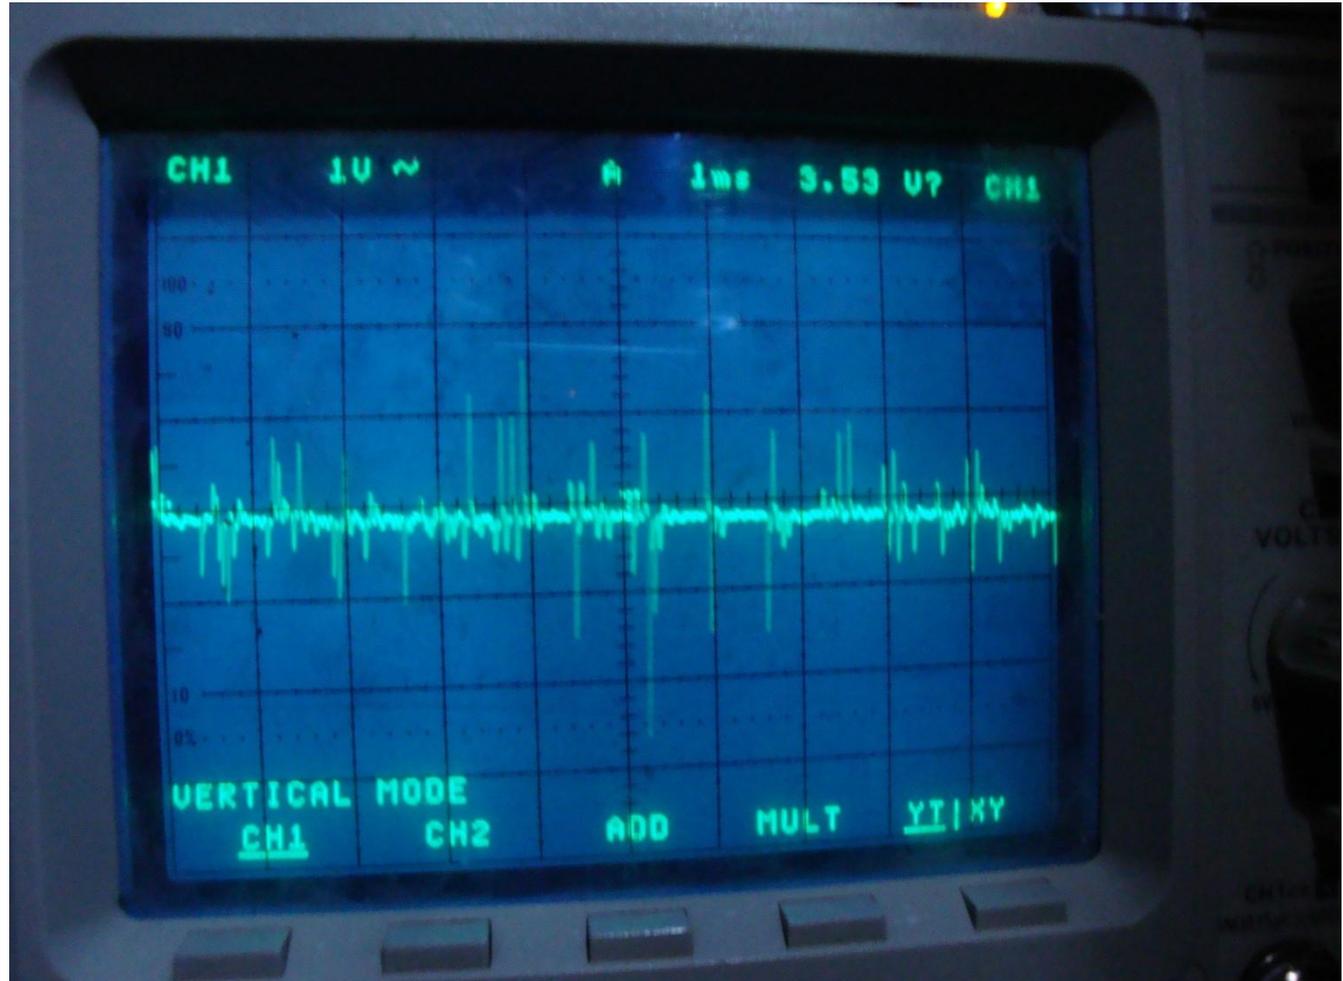
Looking at the CM noise and triggering on the noise peaks, the amplitude of the spikes increased from 15-20 volts to now 25-30 volts.
