CCD production testing progress

CCD production testing

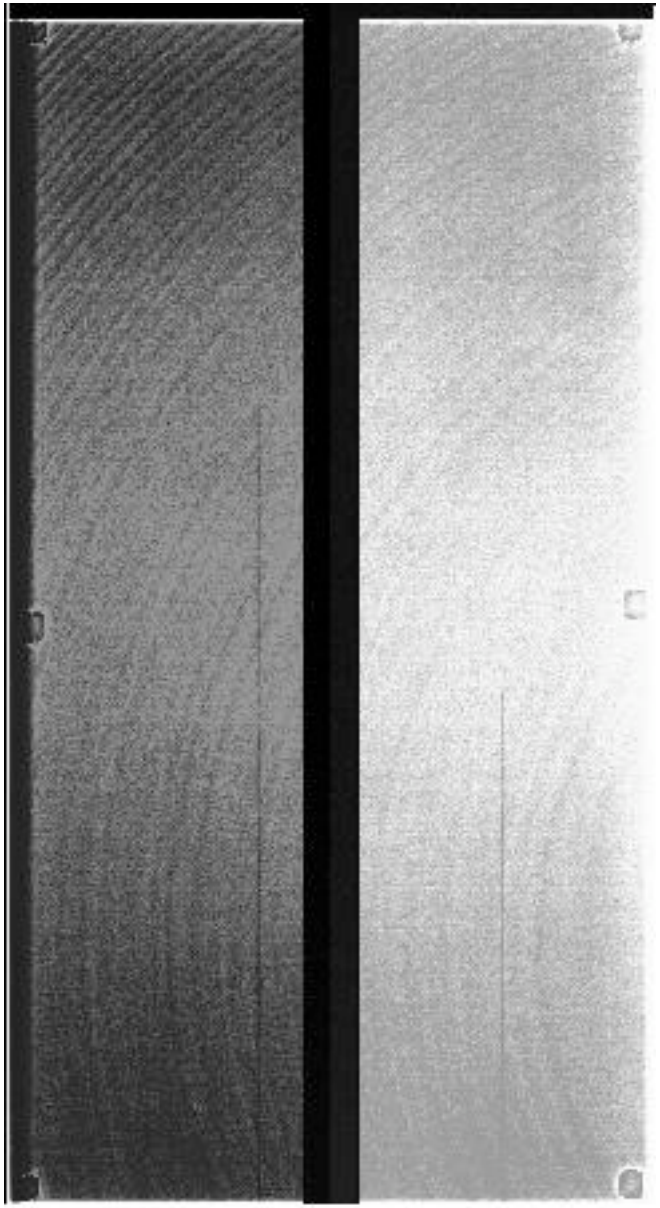
- S3-98 (was -1 now 1) *(Stage1 and Stage2) Typhoon*
  - Evidence for bad V CTI in Fe55 and EPER as shown on following slides.

S3-98 fails V CTI on right and left

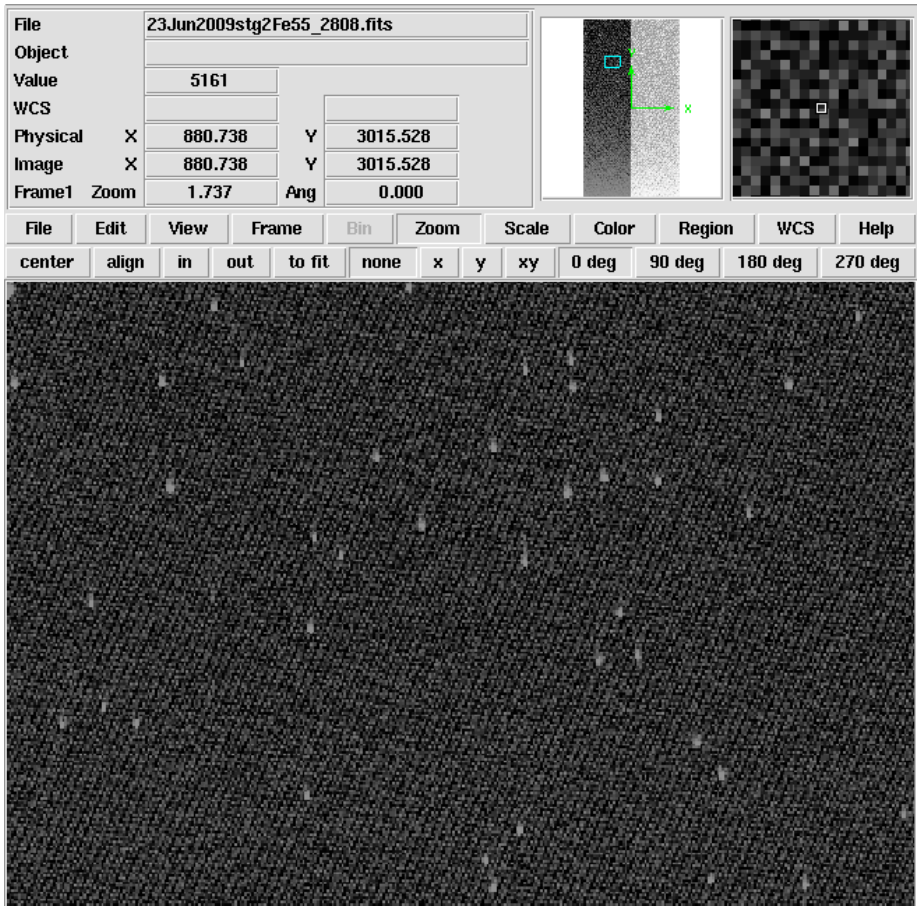
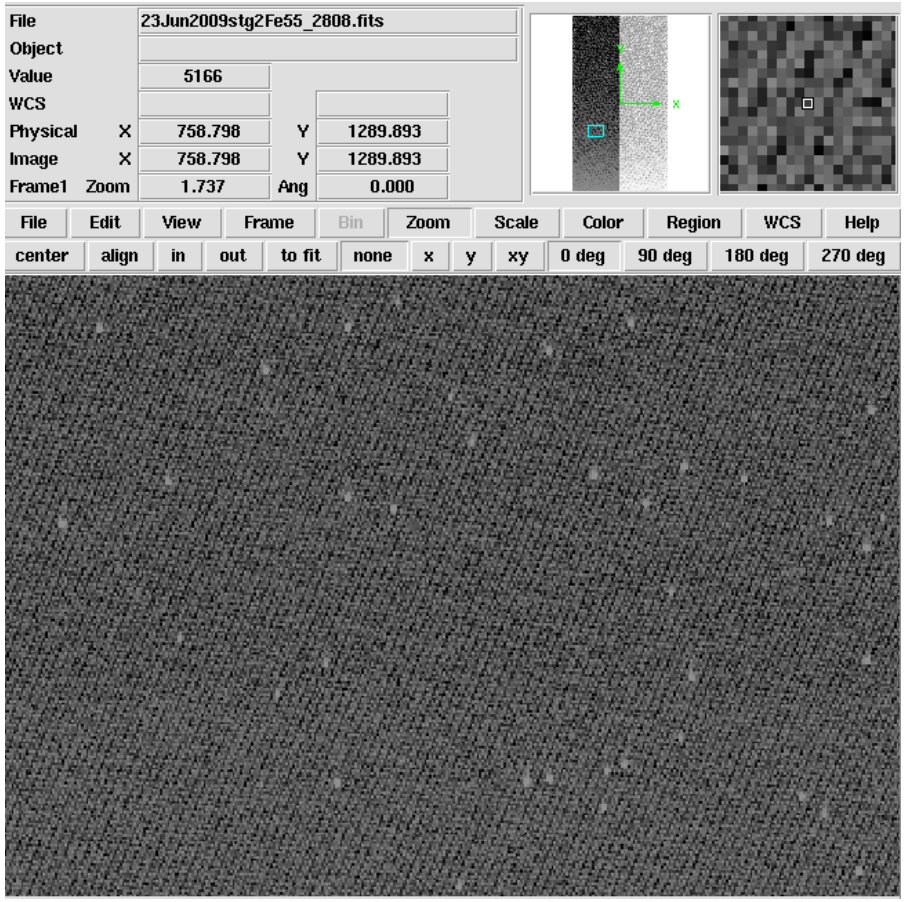
^{55}Fe left top

S3-98 (left side)
Evidence for bad V CTI in ^{55}Fe Images

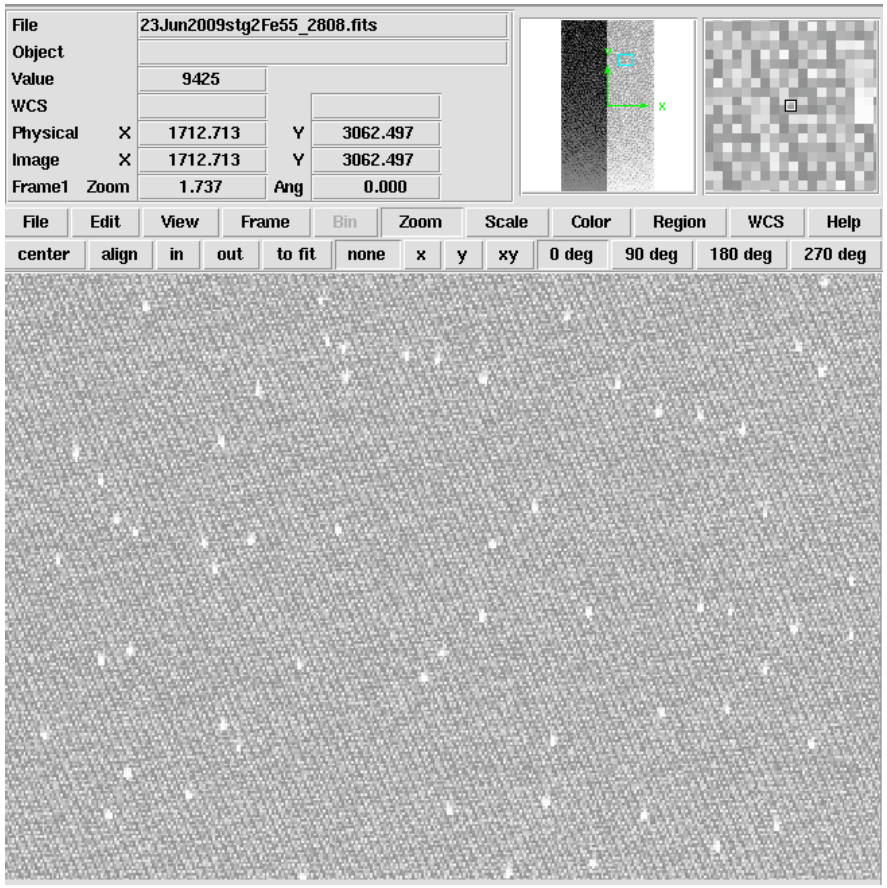
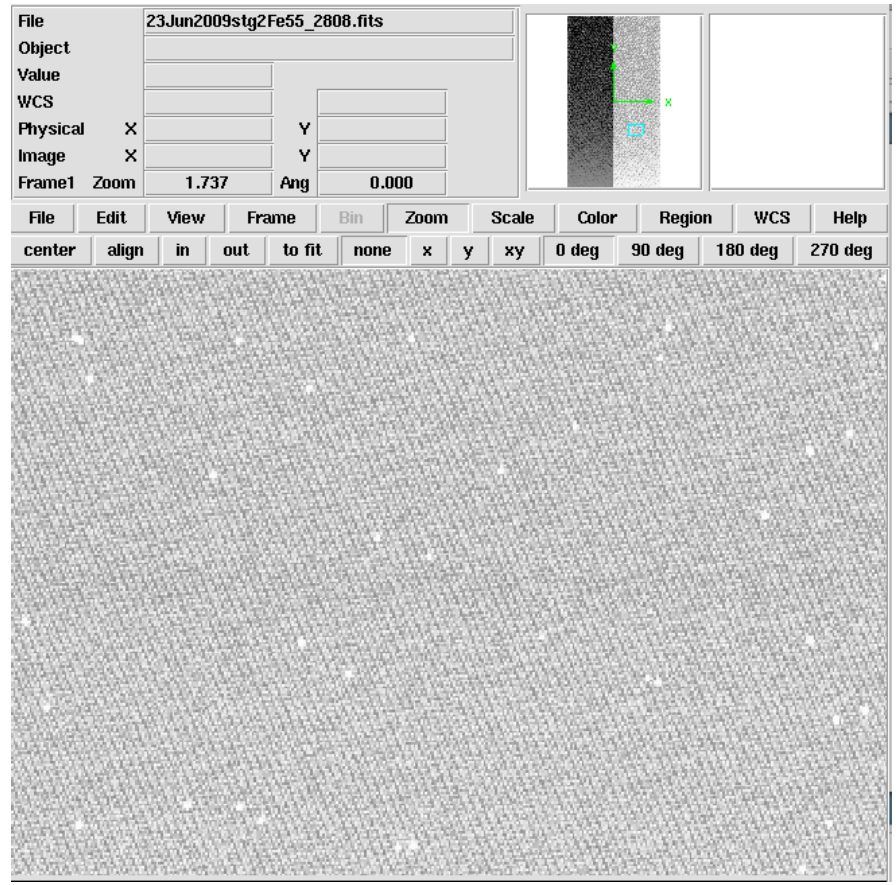
^{55}Fe right top

S3-98 (right side)
Evidence for bad V CTI in ^{55}Fe Images

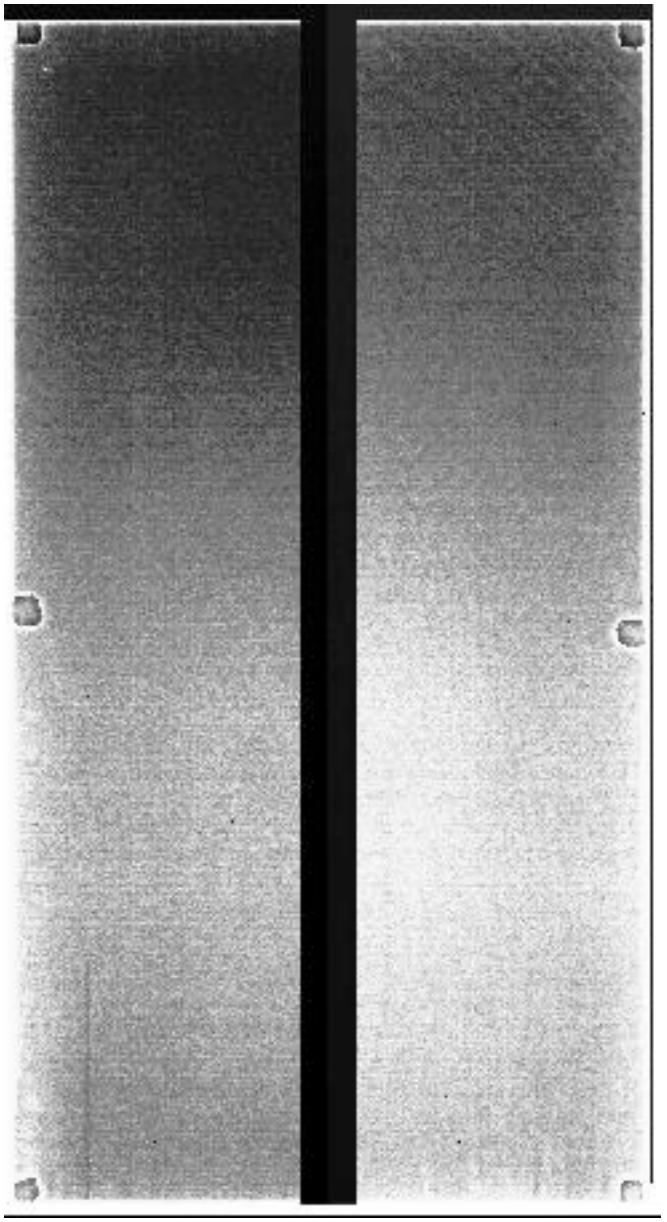
S3-165

grade 2

science

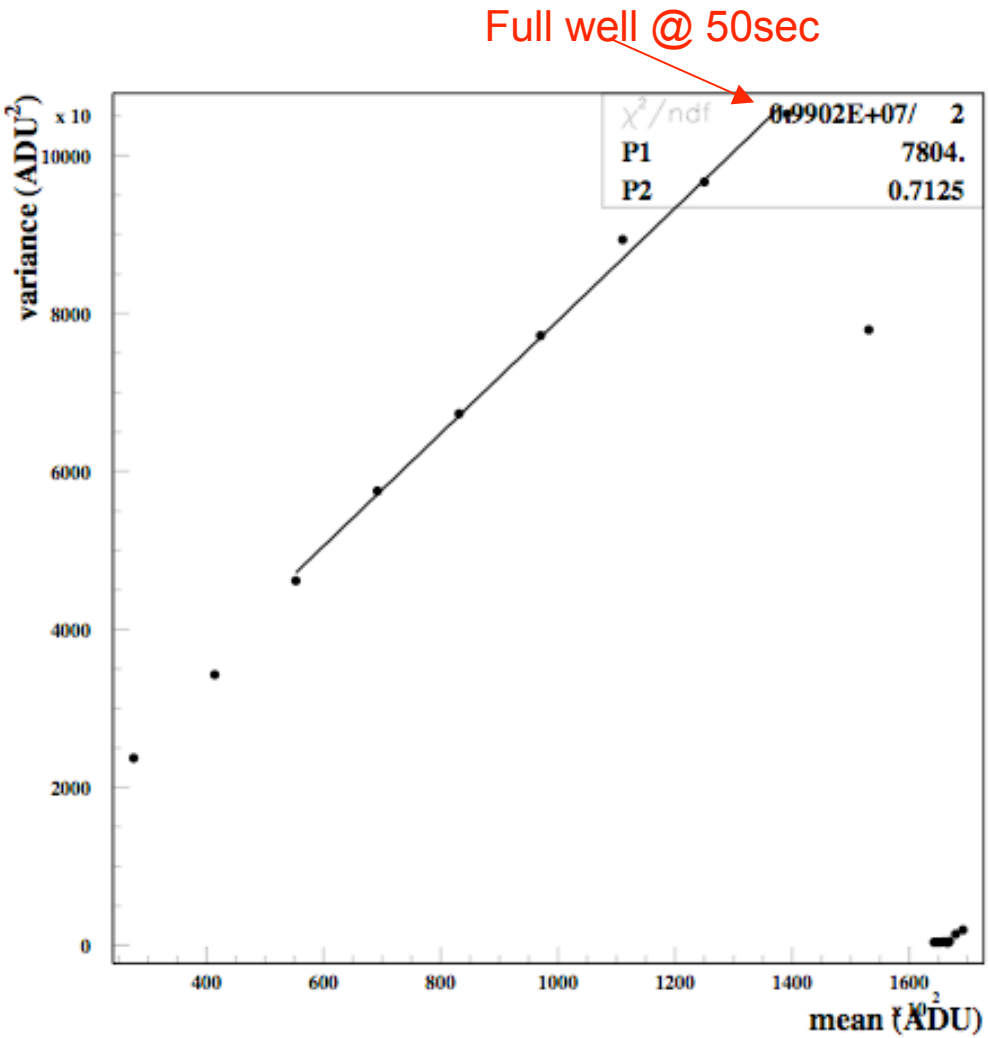
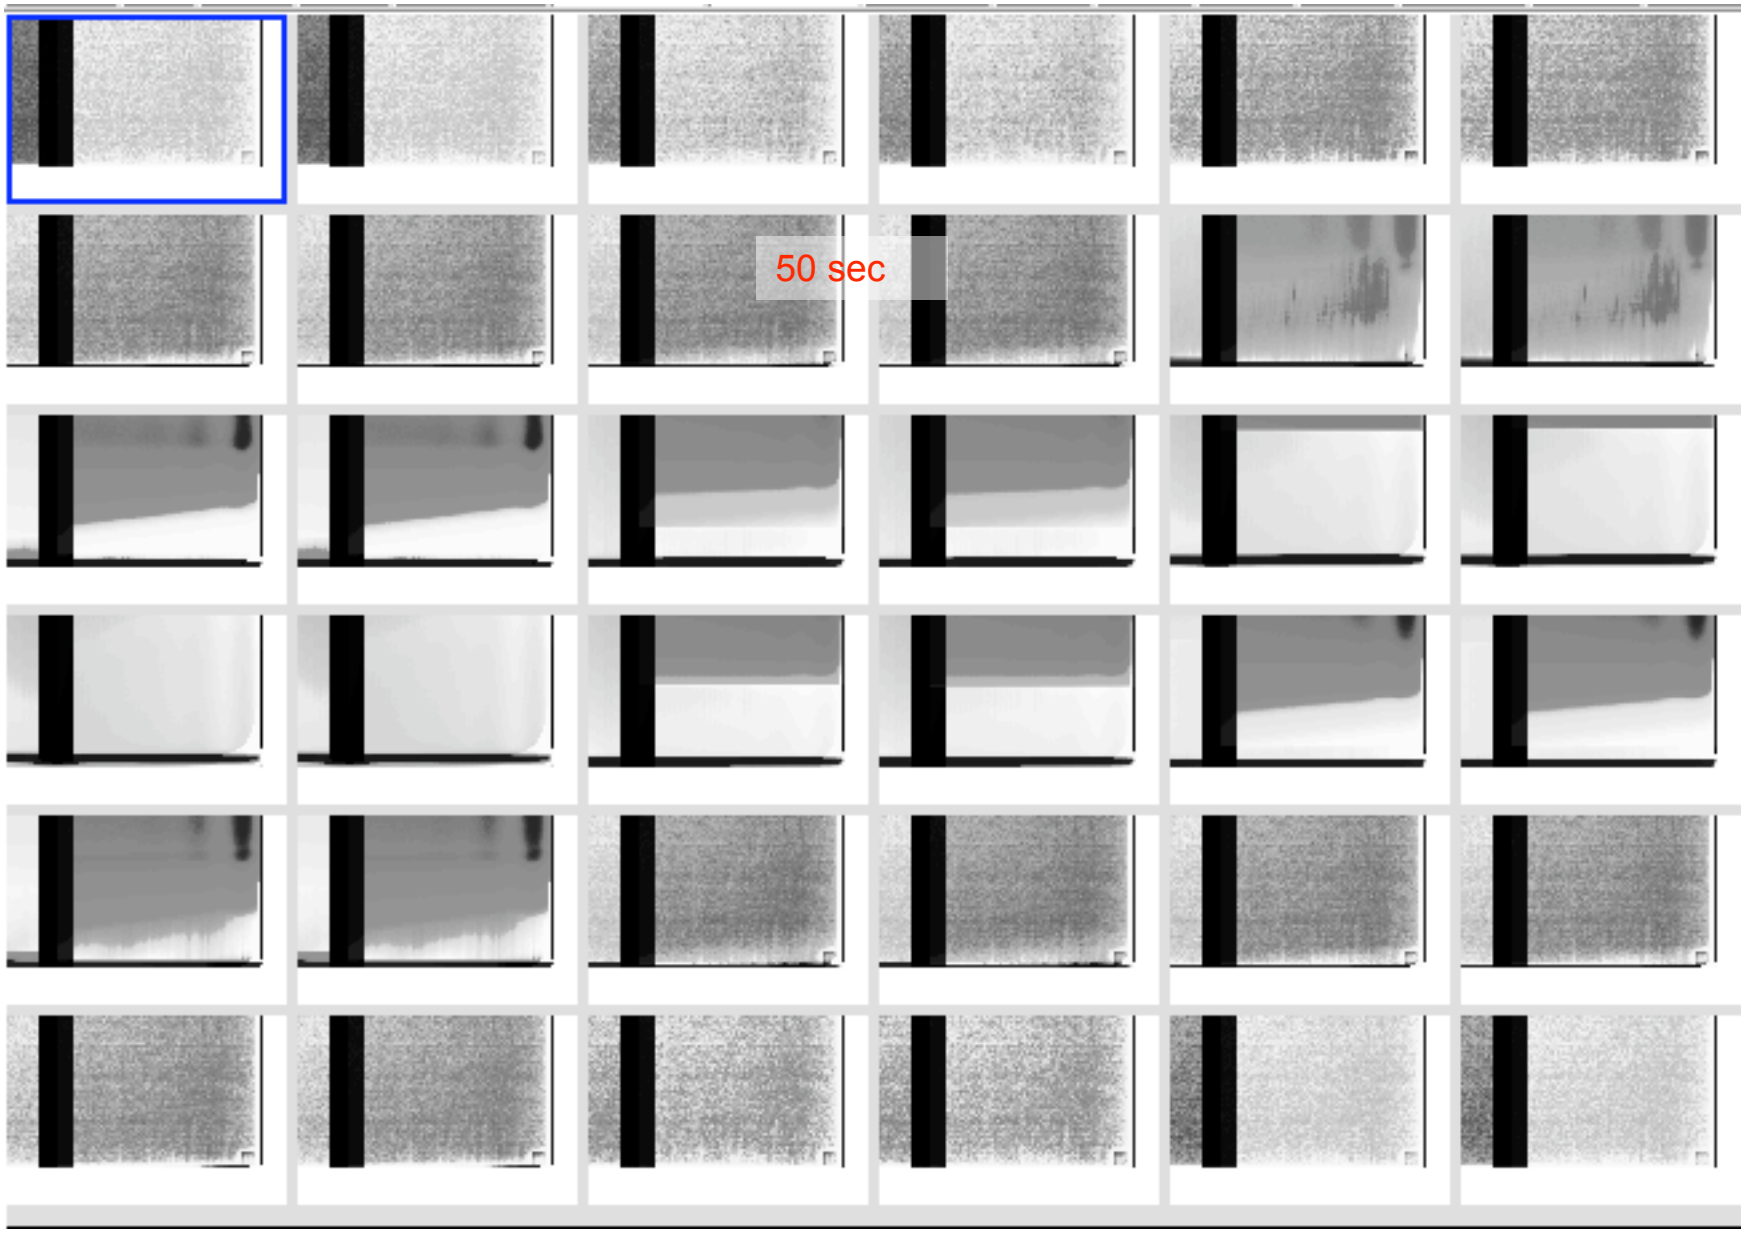
S3-165

- The following 2 slides (and a few similar pairs of slides shown for other CCDs later in the presentation) show the exposure time corresponding to full well and the bottom right region of the CCD corresponding to full well.
- I just want to be sure we aren’t getting some bad regions on the CCD when we claim we are at full well.
- We talked about this last week, and the glowing edge on the bottom is saturating as we near full well.
- So I think it’s ok, but I’d like others to look at this.

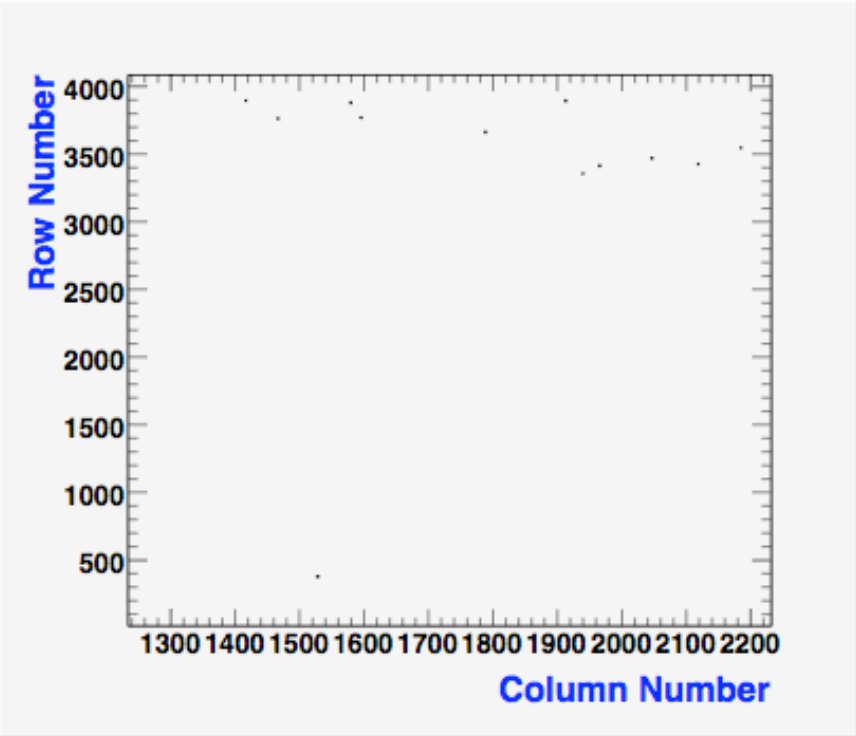
Figure 26: Trap location of the rightside of the CCD

More potential traps than usual

- 17 potential traps (not looked at by Steve & Hal yet, so some may be skyscrapers)
- But it's Interesting that they are all near the top
- Only a few are coincident with cosmetic defects

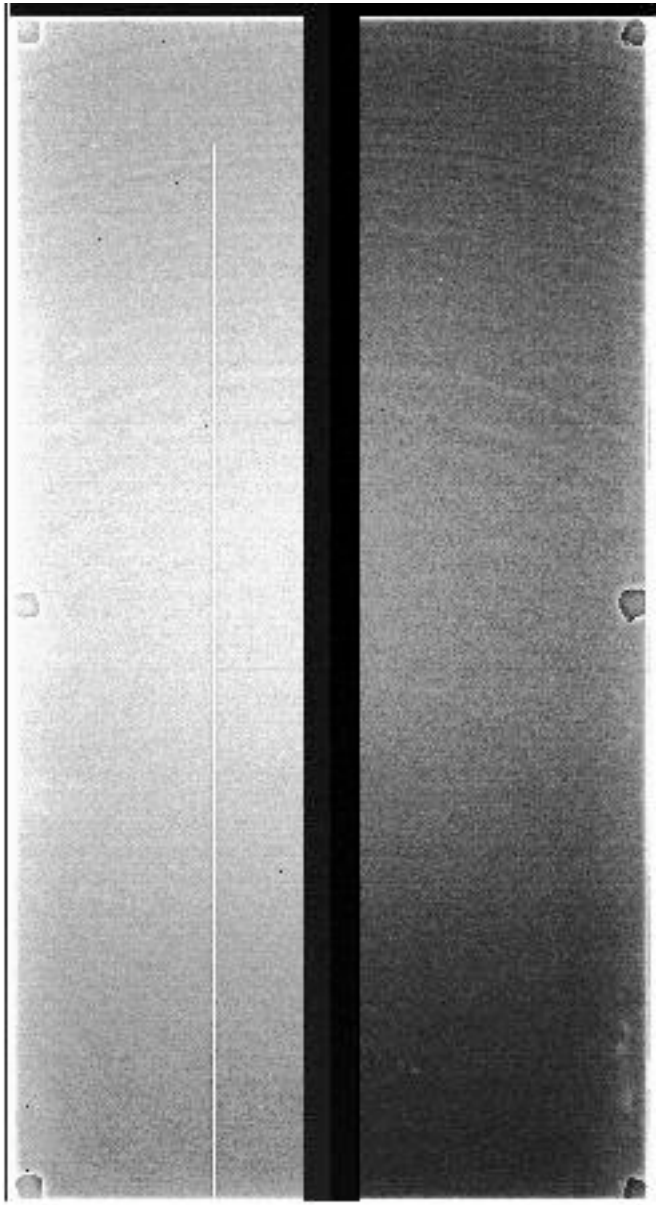
S3-166

grade 2

science

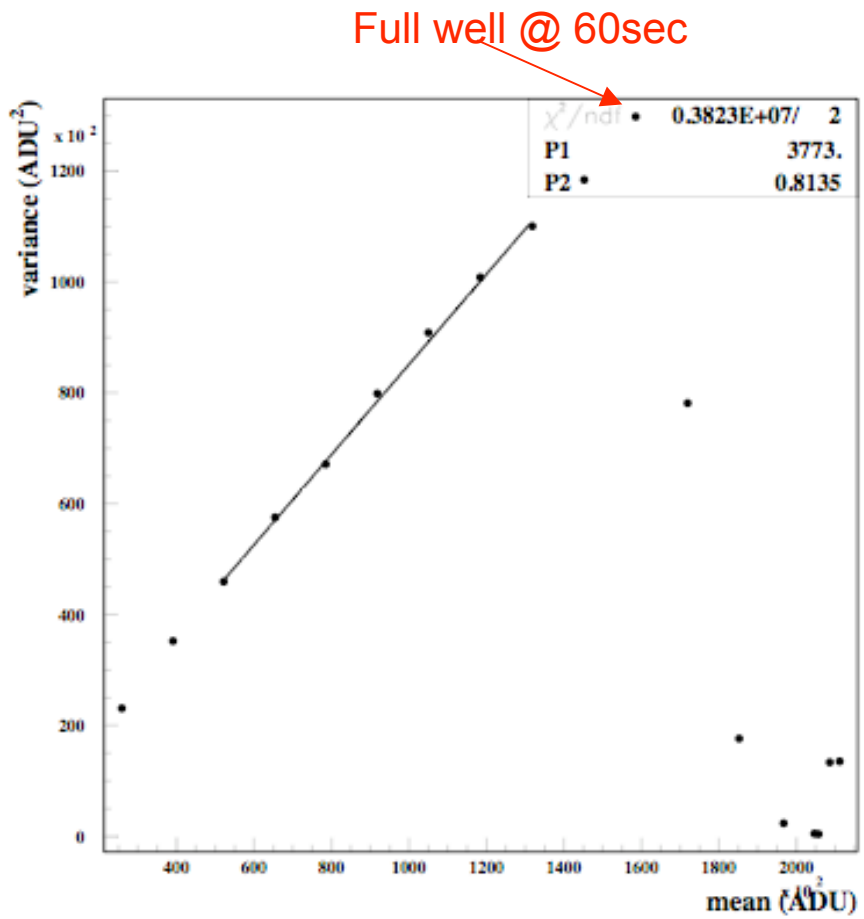
S3-166

Figure 3: Photon transfer curve for the LH amplifier. The line corresponds to a linear fit to the data, the paremeters for the linear fit are shown in the plot.

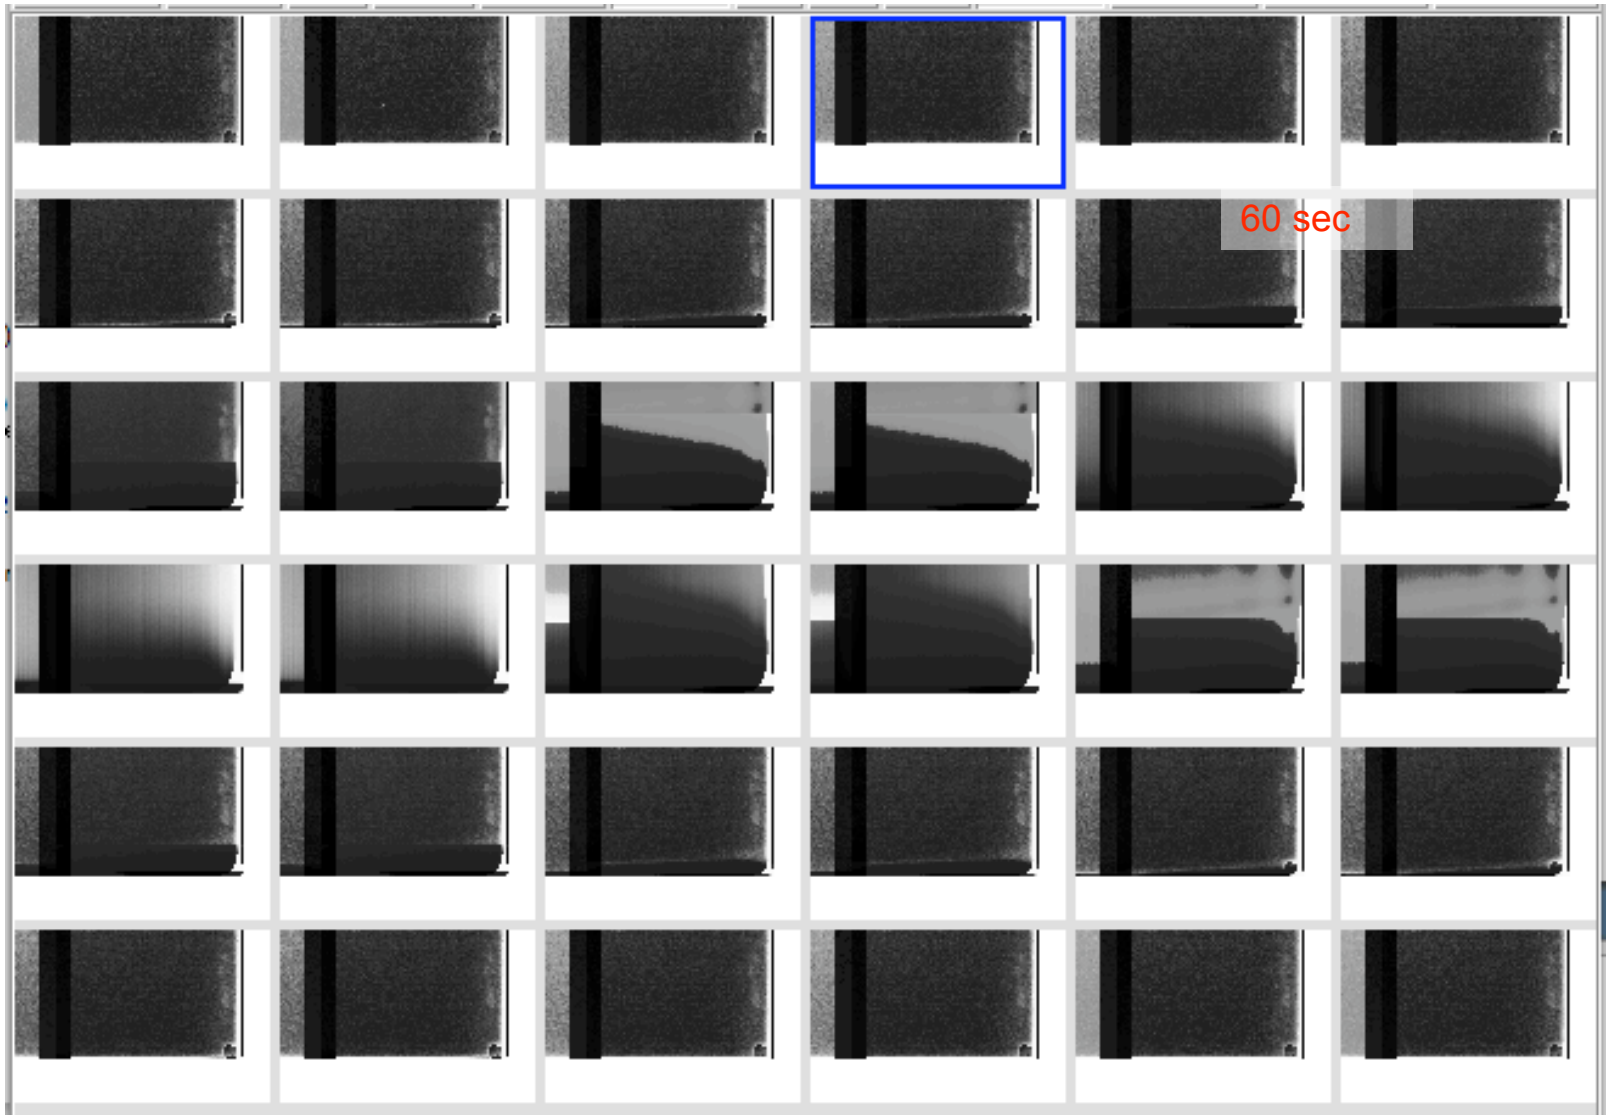
S3-166

Many CCDs have spots like these

Difference between bright and dark ~3%

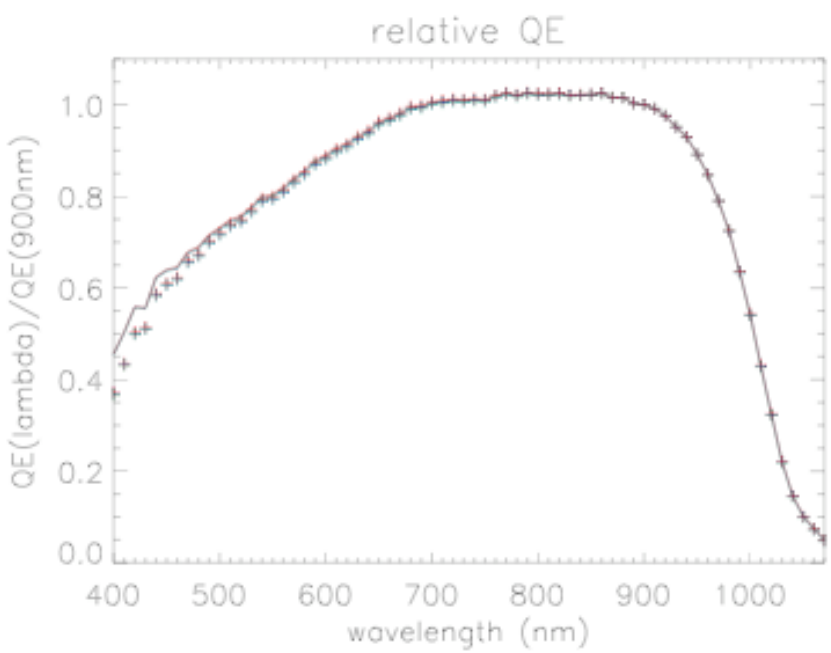
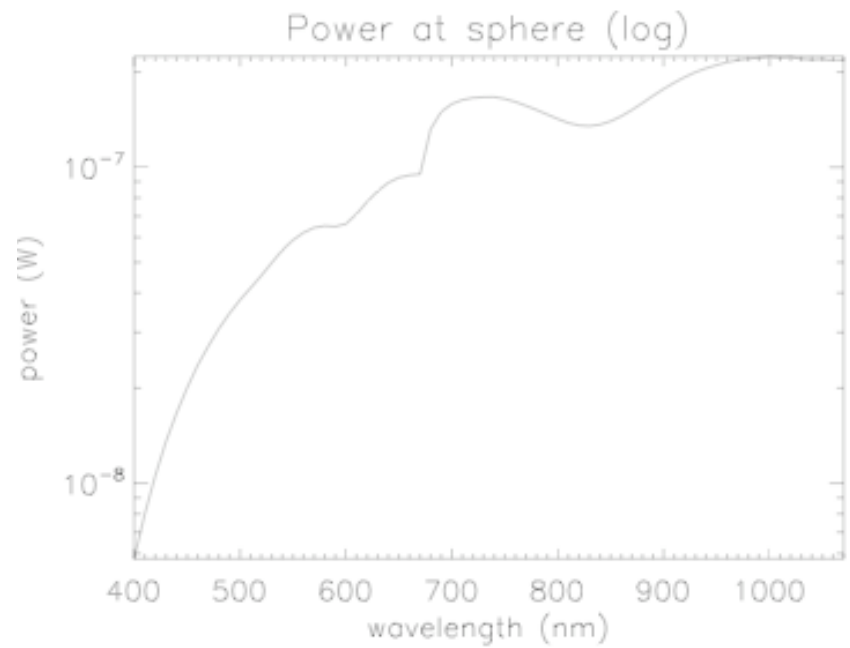
Figure 39: Relative QE with Kfactor applied

S3-166
Right vs. left QE a little different

In the past we saw this when the power at 400-500nm was very low, but in this case the lamp power at 400-500nm is not super-low compared to usual

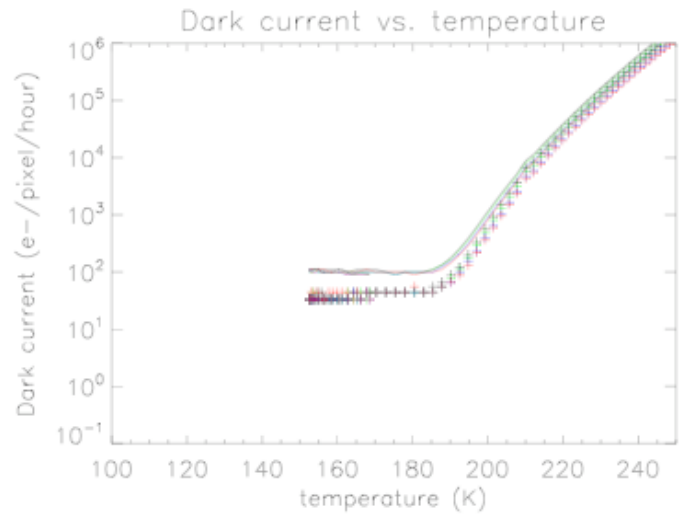
Figure 18: Dark current vs. temperature. The 8 regions on the previous figure are superimposed here for ease of comparison.

Left dark current a little higher (marginal)

Amp	Dark Current (e/hour)
Left	27.675276
Right	10.962241

This measurement does *not* use blank off plate so dark current is higher

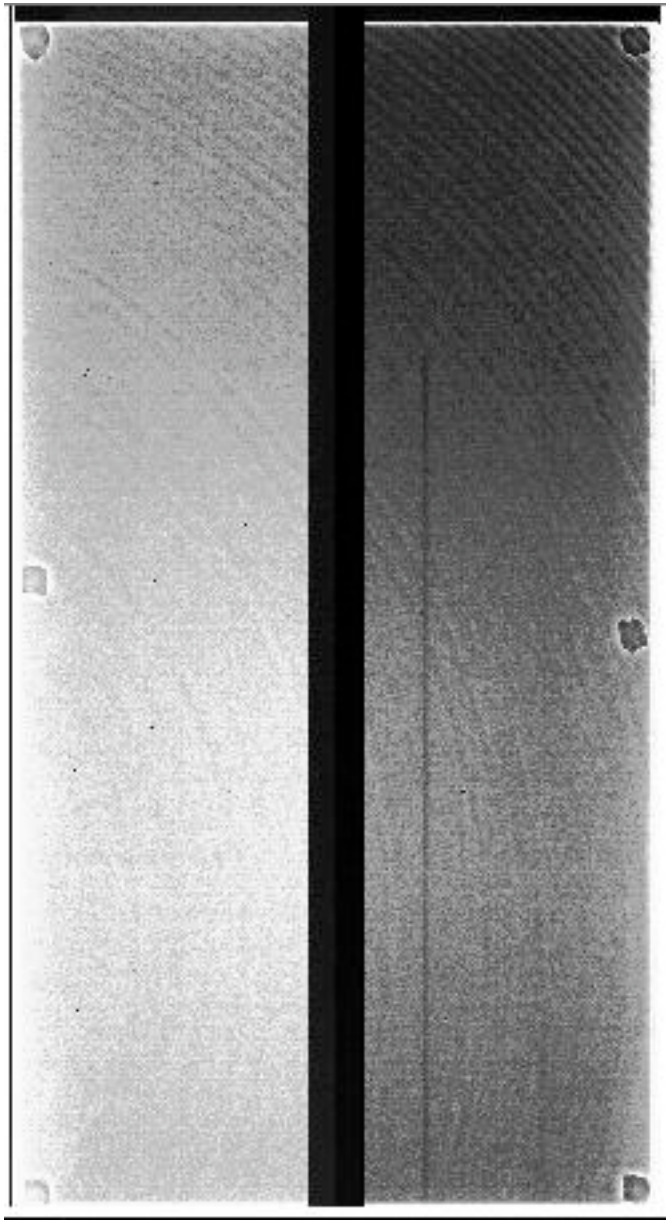
S3-152

bad V CTI in EPER and ^{55}Fe

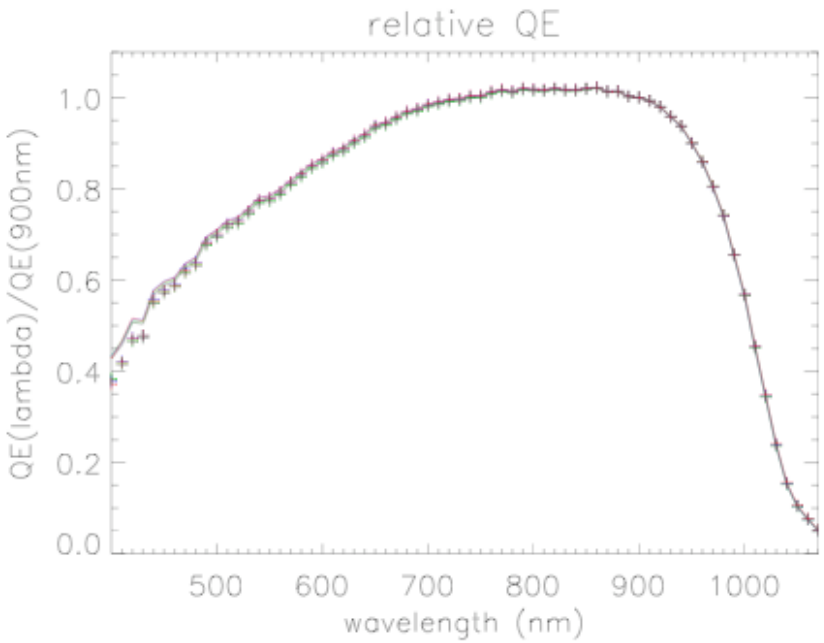
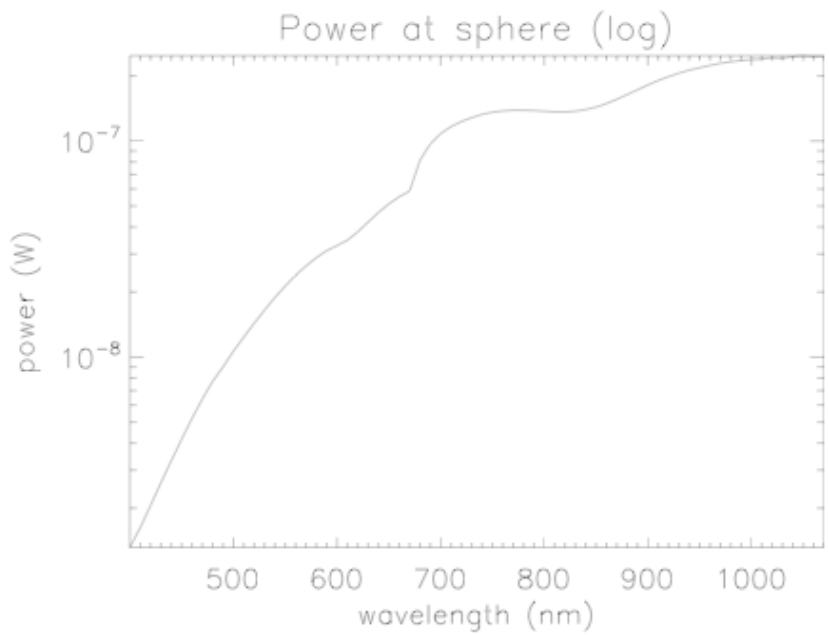
Figure 39: Relative QE with Kfactor applied

Right vs. left QE a little different

Power is low at 400-500 nm

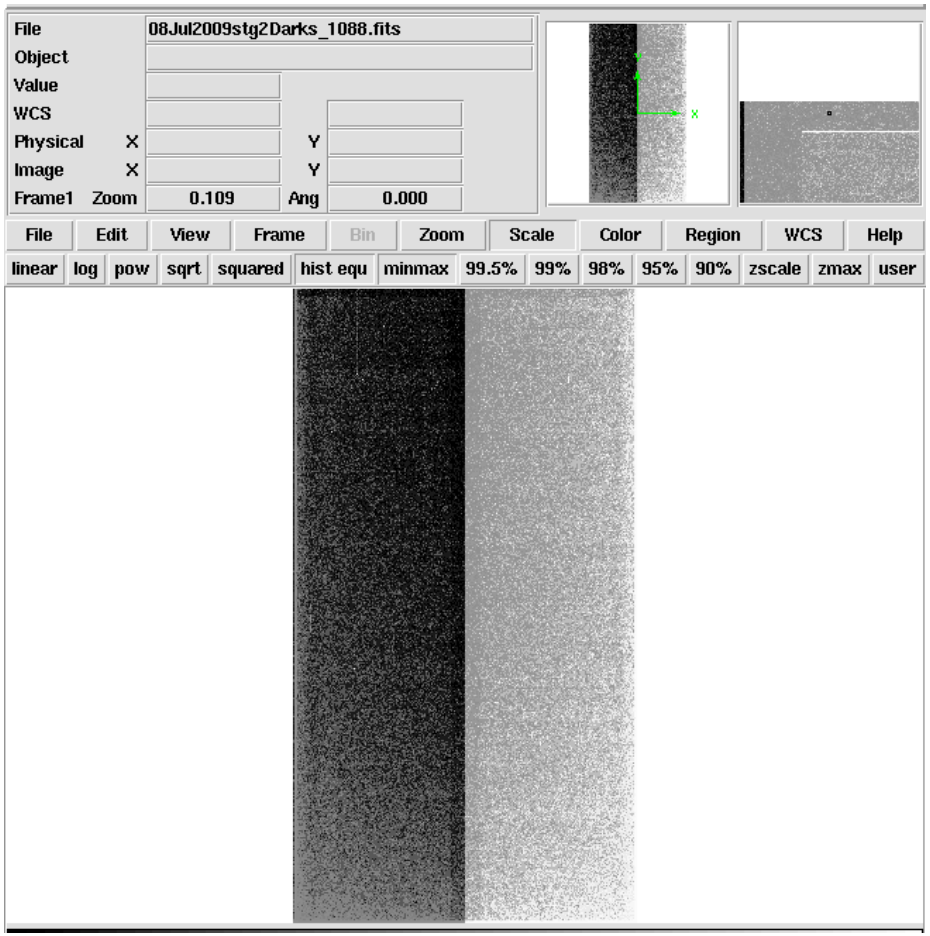
400 second dark

S3-171
marginal dark current

Amp	Dark Current (e/hour)	(ADU/400s)	Std Dev (e/400s)	Min (e/400s)	Max (e/400s)
Left	34.134007	3.0000000	4.9453219	-17.067004	24.020227
Right	34.793813	3.0000000	5.1912717	-16.108247	28.994845

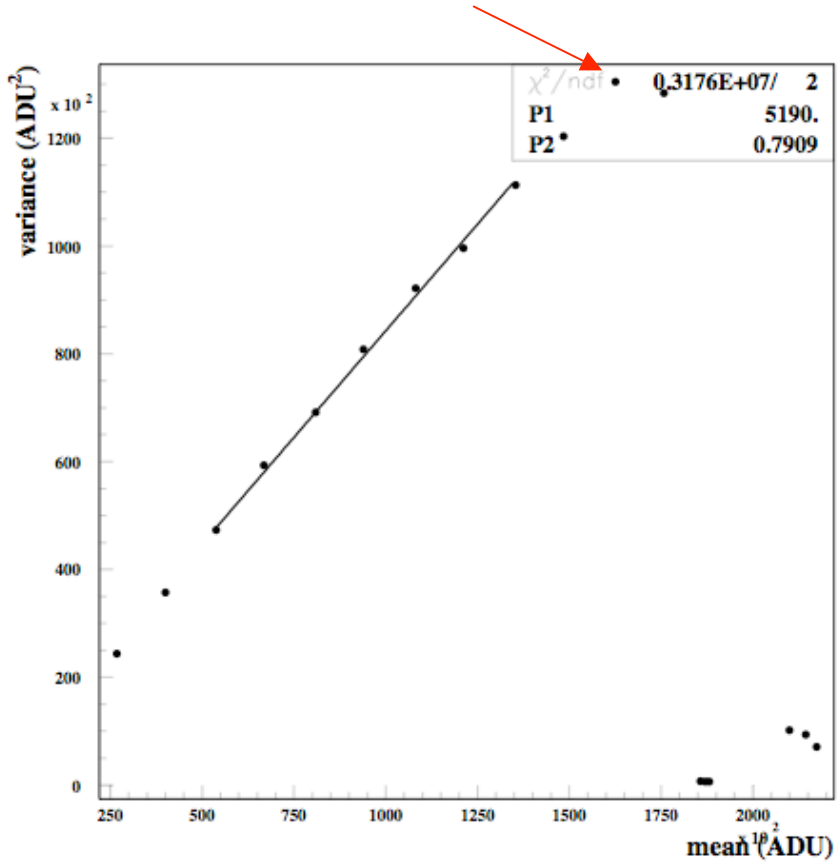
S3-171

Full well @ 60sec

Figure 3: Photon transfer curve for the LH amplifier. The line corresponds to a linear fit to the data, the paremeters for the linear fit are shown in the plot.

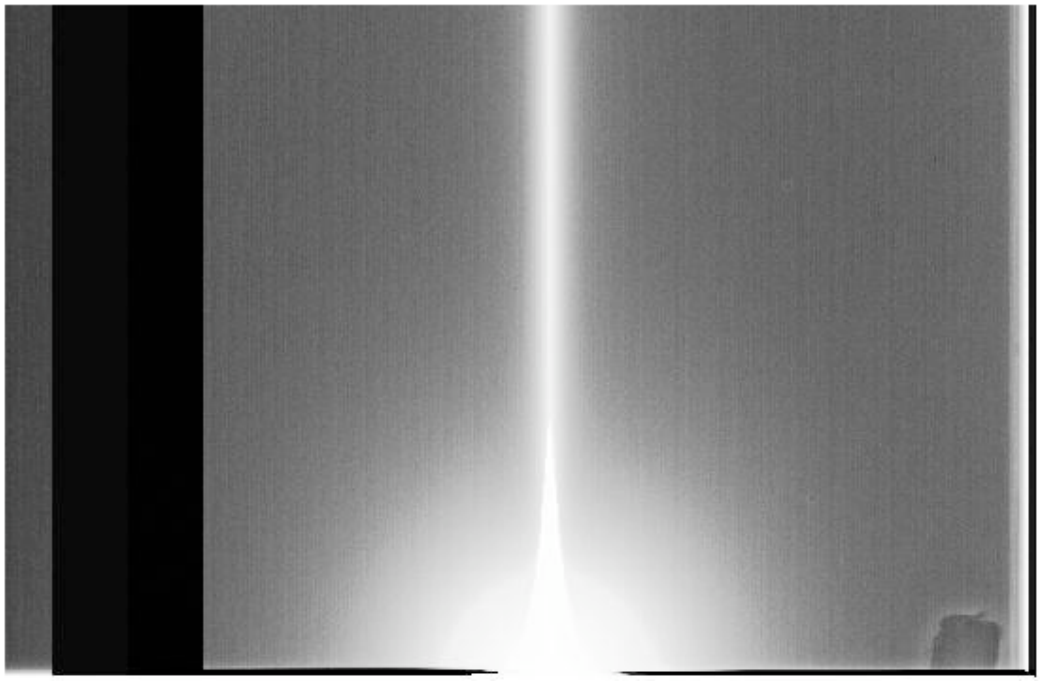
10 sec flat

- S3-165 Grade 2 *(Stage1 and Stage2) Snowstorm*
- S3-166 Grade 2 *(Stage 1 and Stage 2) Windstorm*
  - Dark current on right is marginal (27e-) but assigned grade 2
- S3-152 Grade 1 *(Stage1 and Stage2) Snowstorm*
  - Bad V CTI seen in EPER and ^{55}Fe
- S3-171 Grade 1 (or 2?) *(Stage 1 and Stage 2) Windstorm*
  - Marginal dark current (34e-). Should we rate this as science?
- S3-179 Grade 0 (*No testing*) *Typhoon*
  - Huge glow on right bottom Typhoon

S3-179
grade 0
