# March 2010 FEE Engineering Run at CTIO/Tololo

DARK ENERGY  
SURVEY

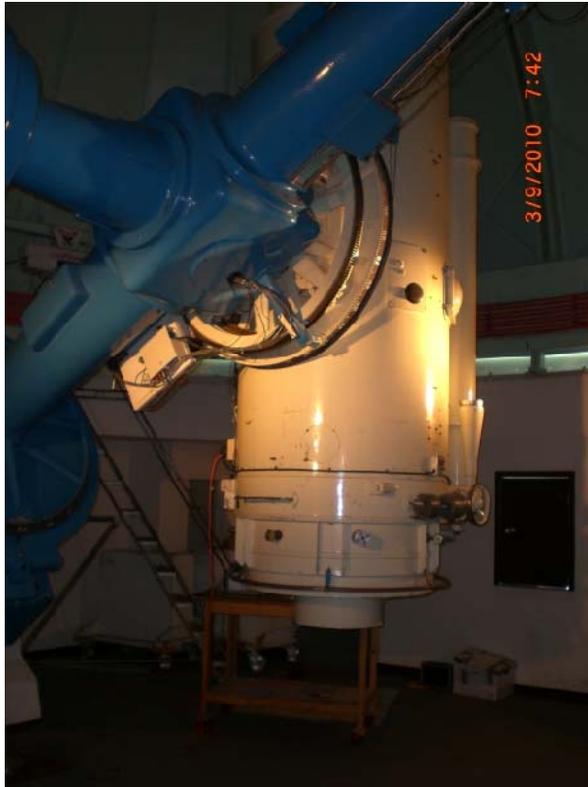
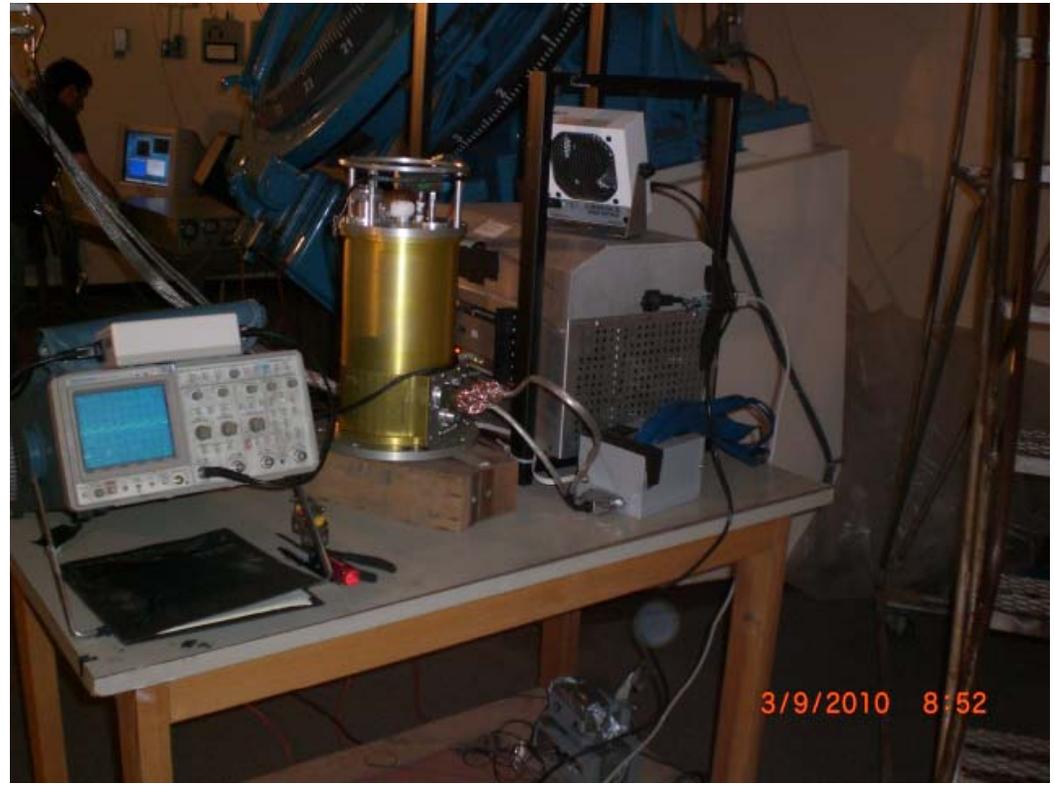
- On Tuesday (the 9<sup>th</sup>), moved the FEE electronics/dewar to the Schmidt building next to the telescope.

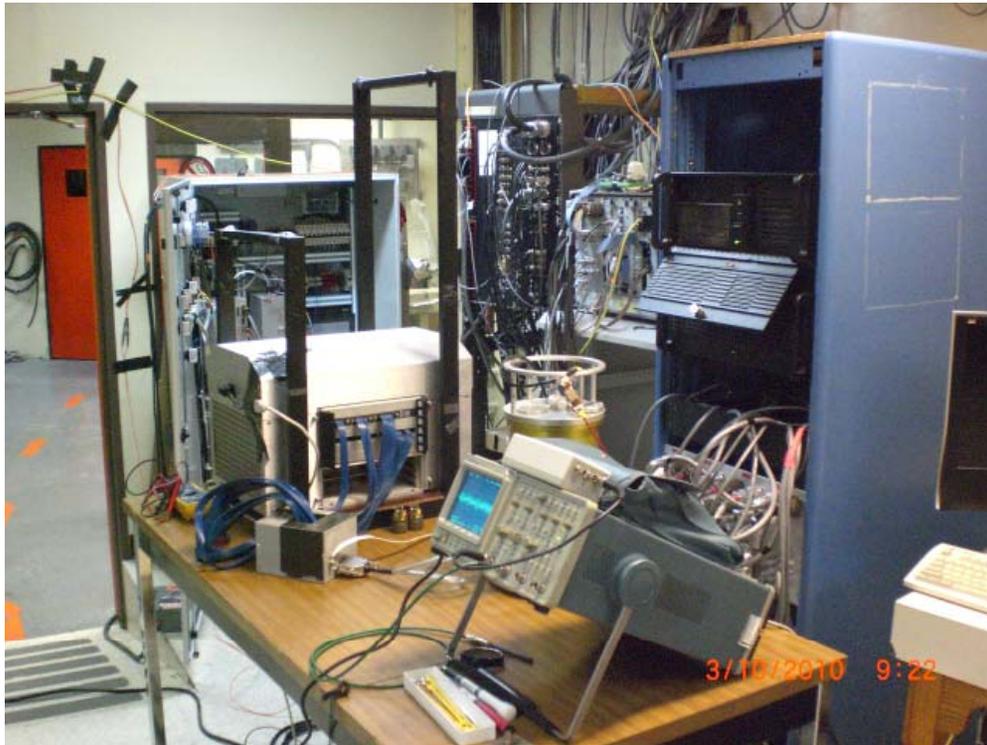
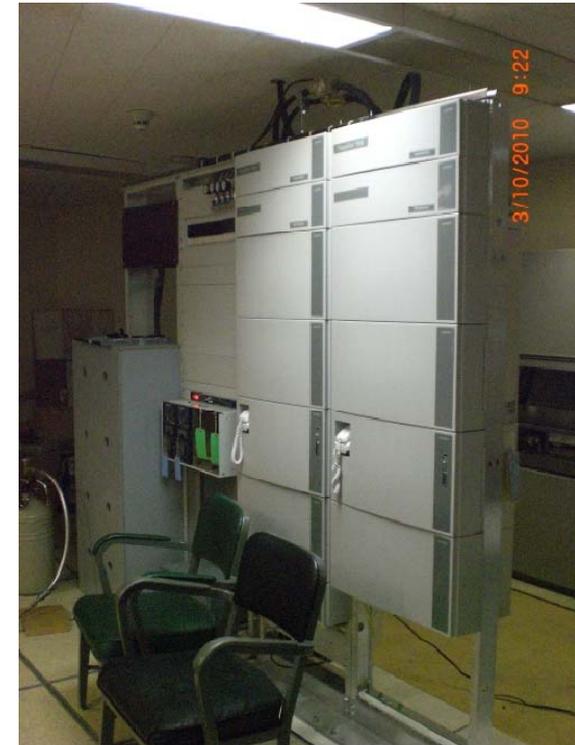
- On Wednesday (the 10<sup>th</sup>), moved the FEE electronics and dewar to the Blanco building on the P-floor in a room next to all the motor driver gear, switching and microwave gear.
